# REHABILITATION OF A 42-INCH INDUSTRIAL PRESSURE PIPE AT PAPER PROCESSING PLANT

<b>Project:</b>	Industrial Pressure Pipeline Rehabilitation
<b>Location:</b>	Charleston, South Carolina
<b>Length:</b>	872 LF
<b>Diameter:</b>	42 inches
<b>Installation:</b>	InsituMain® CIPP

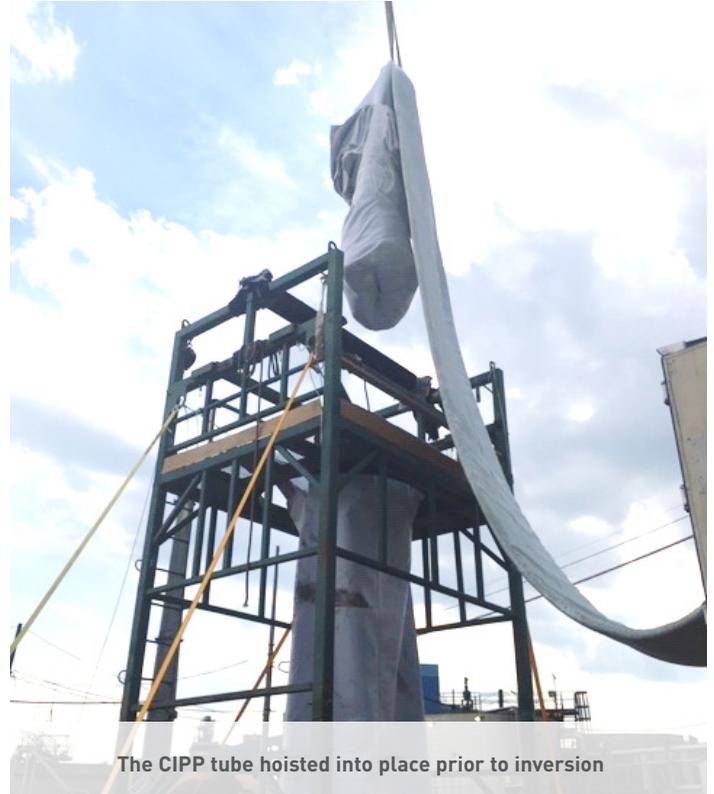
The CIPP tube hoisted into place prior to inversion

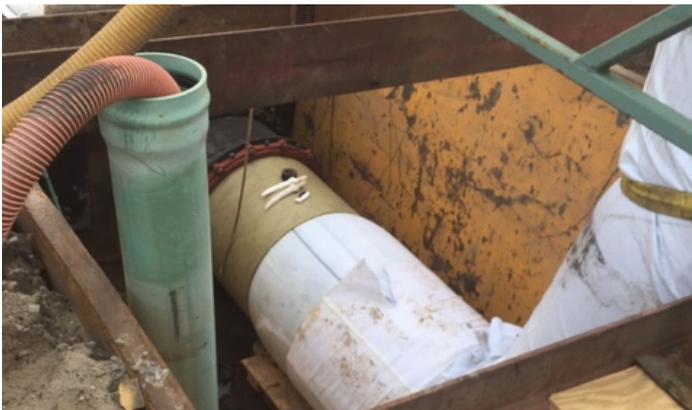
Composite CIPP tube being inverted into FRP end spool piece

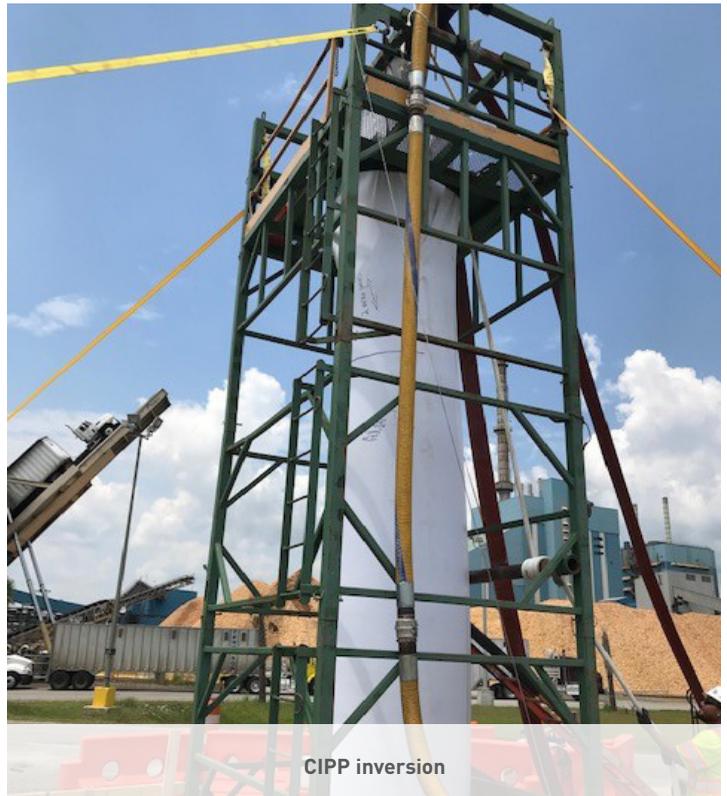
CIPP inversion

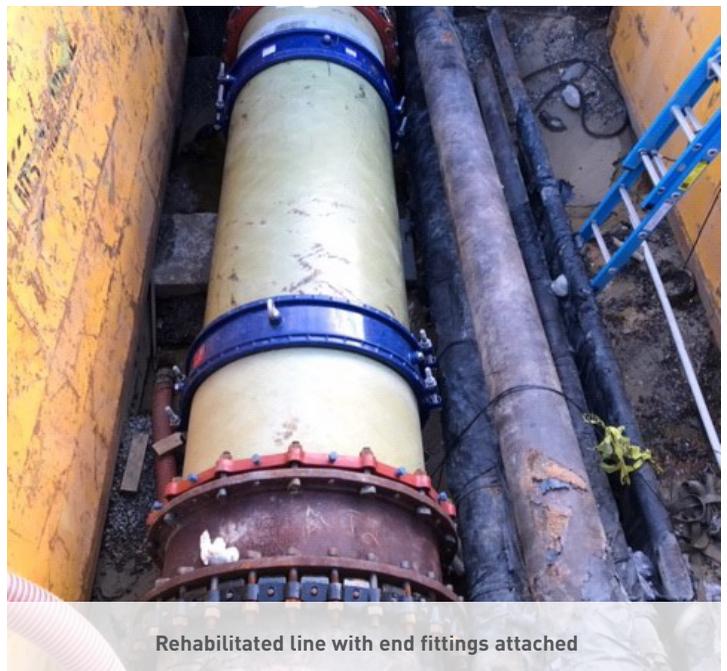
Rehabilitated line with end fittings attached
