# BRISTOL COUNTY WATER AUTHORITY 2019 PVC SLIPLINING OF THE EAST BAY PIPELINE OF THE EAST BAY PIPELINE

By: Paul Smith, P.E., BETA Group, Inc.  
Michael Crawford, P.E., Bristol County Water Authority

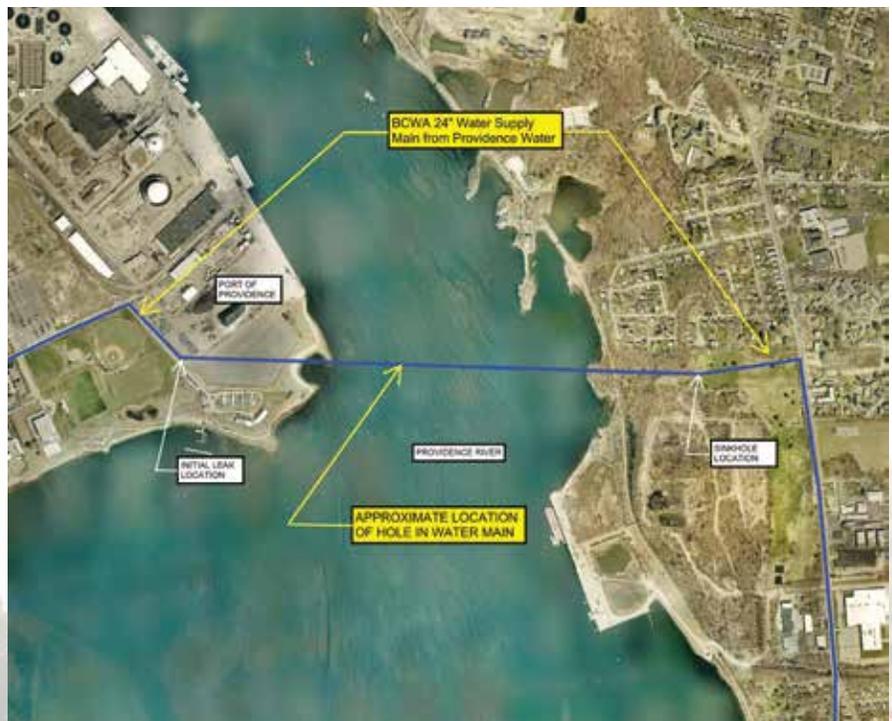
*Critical 4,300-foot 24-inch welded steel main crossing under the Providence River originally installed in 1998 by HDD to a depth of approximately 170 feet in bedrock*

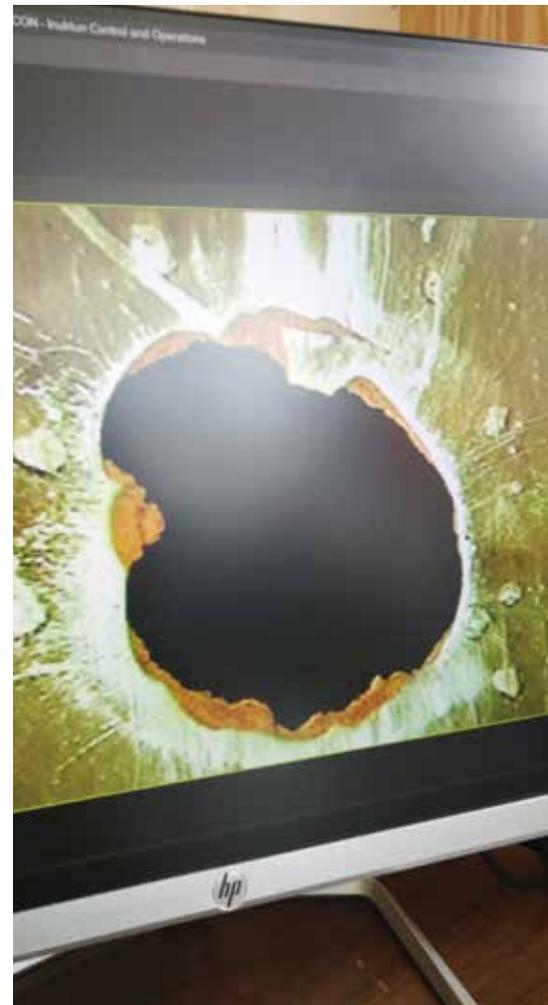
*Two holes were found in the 24-inch steel pipe in bedrock approximately 170 feet beneath the surface of the Providence River*

At this time, BCWA received word that there was a possible sink hole within a golf course on the other side of the Providence River. The sink hole was 4,300 feet away at an elevation of 60 feet higher than the Port of Providence side. Following subsequent testing of the water within the sink hole, it was determined that the water was consistent with potable water and directly related to the active leak. The leak was not in the Port of Providence parking lot, but rather somewhere beneath the Providence River at a significant depth, with potable water conveyed through the rock tunnel to both ends of the tunnel. A televised inspection of the main was critical to identifying the location and nature of the leak. This information would also be critical in evaluating possible repair options. Shortly thereafter, a 2-inch corporation stop was installed on the main in Port of Providence and the main inspected using Pure Technologies Sahara camera which allows for CCTV inspection of active water mains. The camera utilizes a parachute that pulls the camera and camera cable down the pipeline using the existing water system hydraulics to suspend the parachute and drag the apparatus through the pipeline. Inspection revealed two small holes on welds approximately 1,800 feet into the pipeline or roughly in the middle of the river crossing itself. The larger of the two holes

is believed to be approximately 1-inch in diameter. At this location, the main is in bedrock approximately 170 feet beneath the surface of the Providence River. The plan was to complete an inspection of the entire crossing, approximately 5,000 feet, in an attempt to document all defects that could impact rehabilitation or repair efforts. Unfortunately, as the camera came up on the second hole, the parachute got propelled with the flow of water into the hole, lodged and ultimately damaged upon removal from the hole, thus preventing any additional inspection of the pipeline. Therefore, approximately 2,500 feet would go uninspected.

BETA evaluated numerous pipeline rehabilitation options; multiple sliplining technologies and materials were evaluated based on their installation requirements, hydraulic capacity and overall costs. BETA ultimately recommended sliplining the existing water main with an 18-inch DR 18 Fusible PVC Pipe. The Fusible PVC pipe solution provided for the best possible water system hydraulics and met the significant pressure requirements due to the depth of the existing water main beneath the river. Due to the unknown condition of the remainder of the water main, the project was bid to include CCTV inspection of the entire main and the pulling of a 90-foot “prover” piece. The purpose of the “prover” piece was to evaluate the condition of the PVC pipe once pulled through the existing host pipe. This information would be used to evaluate if the pull resulted in any significant defects to the pipe, and if any adjustments would be required during the final pull. The job was designed and bid over the months of July and August in order to allow for construction to be completed in the fall. The pipe was pre-ordered by the Owner in order to avoid any lead time issues which would have prevented the pipe from being installed in the scheduled timeline.

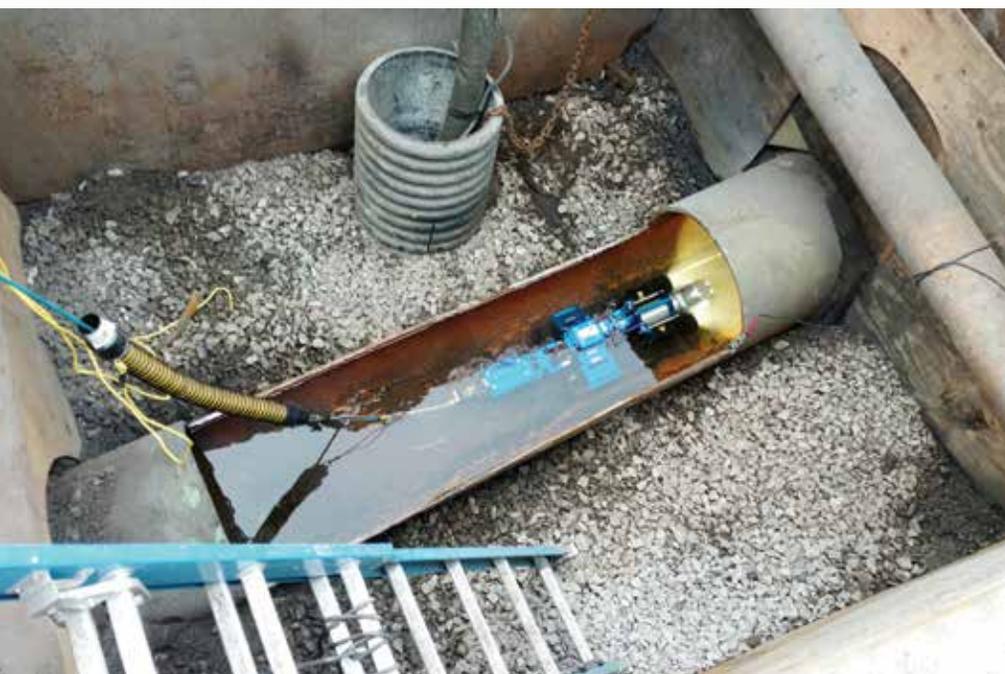
*CCTV inspection of the main was critical to identifying the location and nature of the leak*

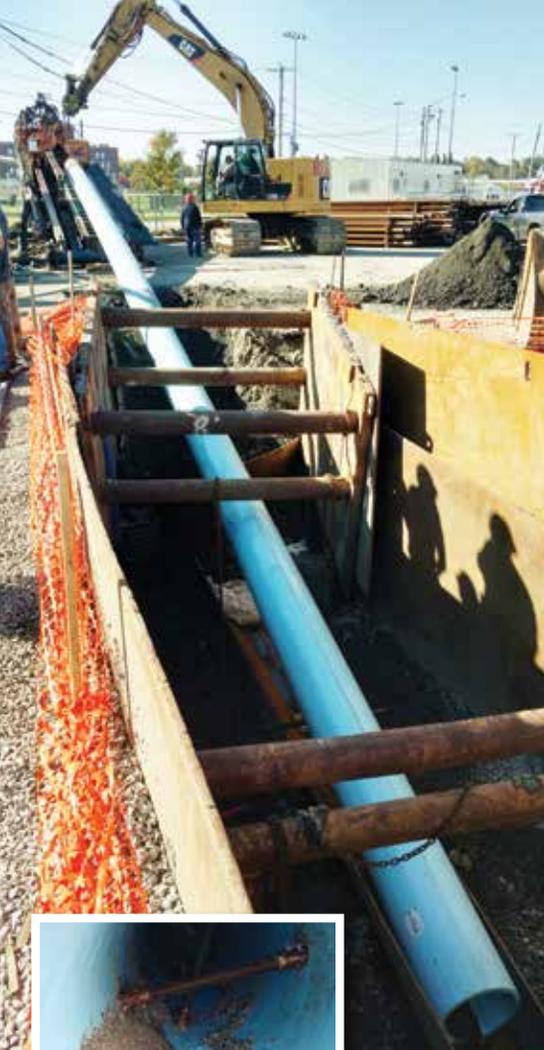
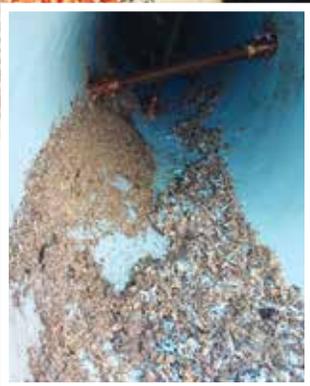
*90-foot "Prover Piece" revealed an unanticipated issue as shreds of the host pipe's epoxy coating were sheared off during the pull and debris sucked into the PVC pipe*

discovered that a significant amount of debris consisting of pulverized pieces of the existing steel pipe's epoxy liner had been ground off the pipe, kicked into suspension and sucked into the PVC pipe during the pull. A solution to this issue was required before completing the final pull, as this material would significantly complicate disinfection of the new water main should this happen during the sliplining operation.

two 45-foot lengths of PVC pipe fused to together was pulled through the host pipe towards the Providence side of the river. The prover revealed only superficial scratches to the pipe exterior. However, the prover did reveal an unanticipated issue. Once the drill head was removed it was

the plug, causing the plug to migrate away from the head, lodging itself within the pipe in an irretrievable location. Ultimately, BETA and BCWA decided to install a concrete plug behind the drill head. To install the concrete plug, a section of PVC pipe was inserted into the drill head and locked in with the drill head pins. The head was then placed vertically, and the PVC was filled with a 8-foot concrete plug, with the pins locking the concrete in. The drill head with concrete plug was then fused onto the first section of PVC pipe to be pulled.

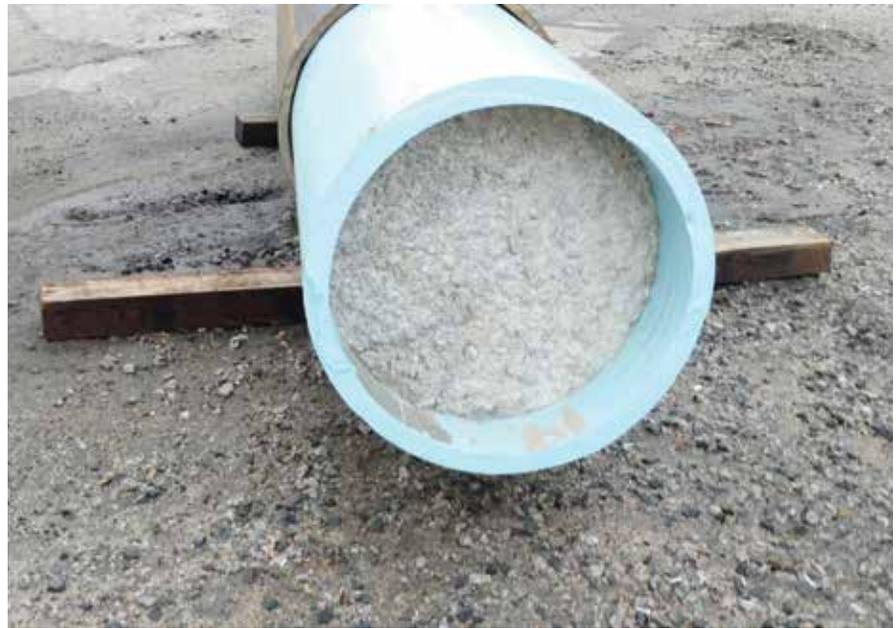
*Pull head needed to be watertight so a concrete plug was fused onto the first section of pulled PVC pipe*

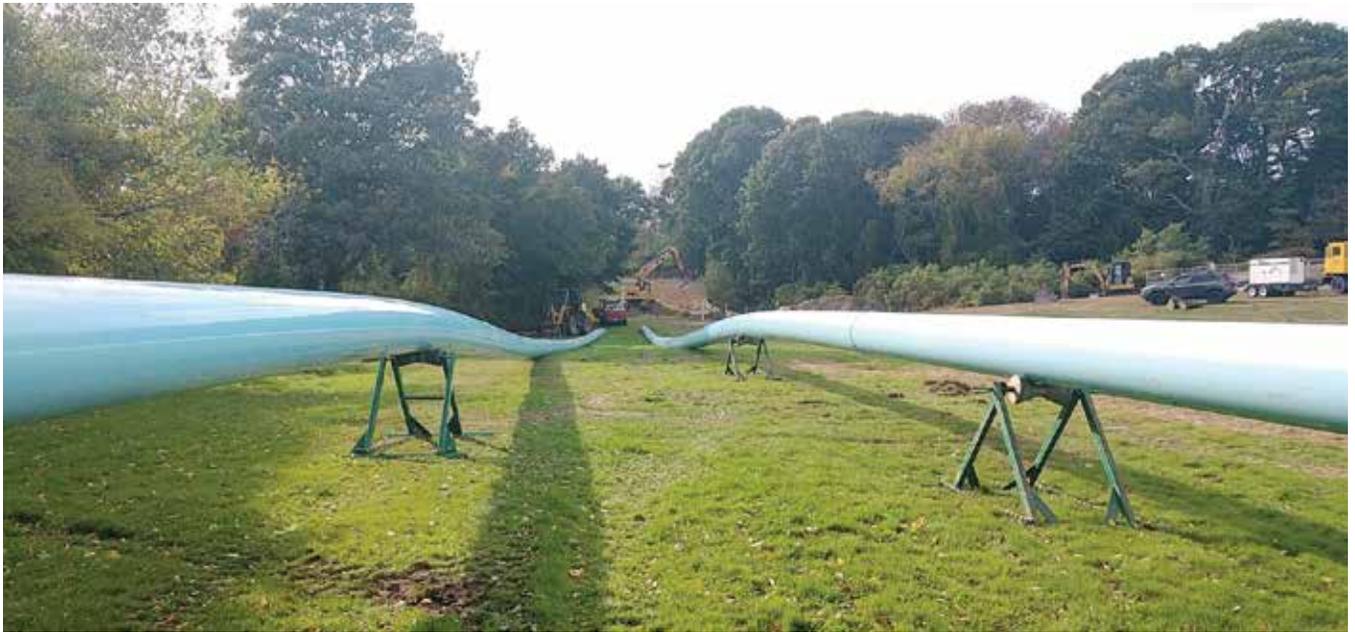
*Fusing of PVC pipe segments was done at the golf course on the East Providence side of the river*

Pipe staging and fusing of the PVC pipe segments occurred at the golf course on the East Providence side of the Providence River. The PVC was fused into 450-foot lengths, 10 sections of pipe, and air pressure tested to 5 psi to confirm that there were no issues with the fused

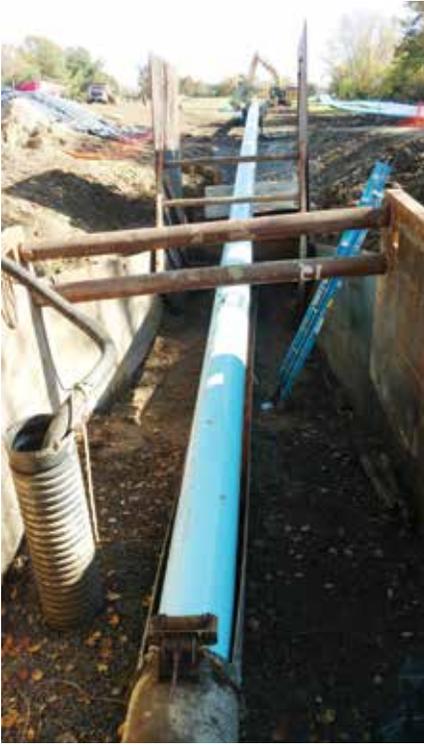
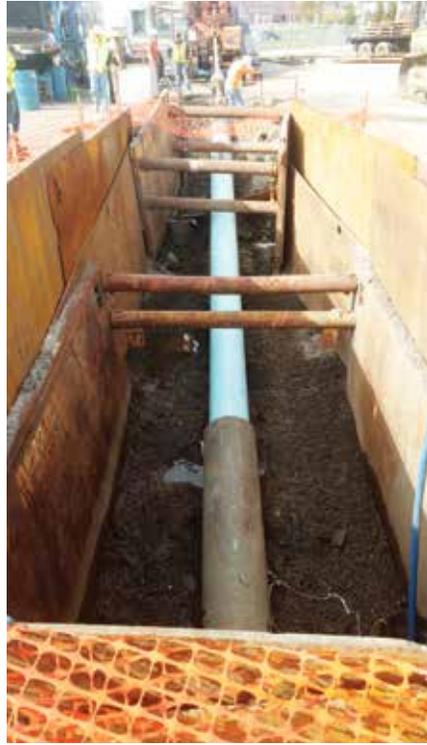
*PVC pipe was pulled from the golf course side of the river to the Port of Providence side. Sliplining pull completed in 3 days*

The sliplining pull was completed over the course of 3 days. The pullback process consisted of pulling of each 450-foot length, then filling the installed length from the tail to ballast the PVC section within steel host pipe. Once the entire pipe was installed, it was successfully pressure tested to ensure continuity following the pullback and intermediate fused joints that were not subject to the initial test. Grouting of the annular space was completed on each side to stabilize

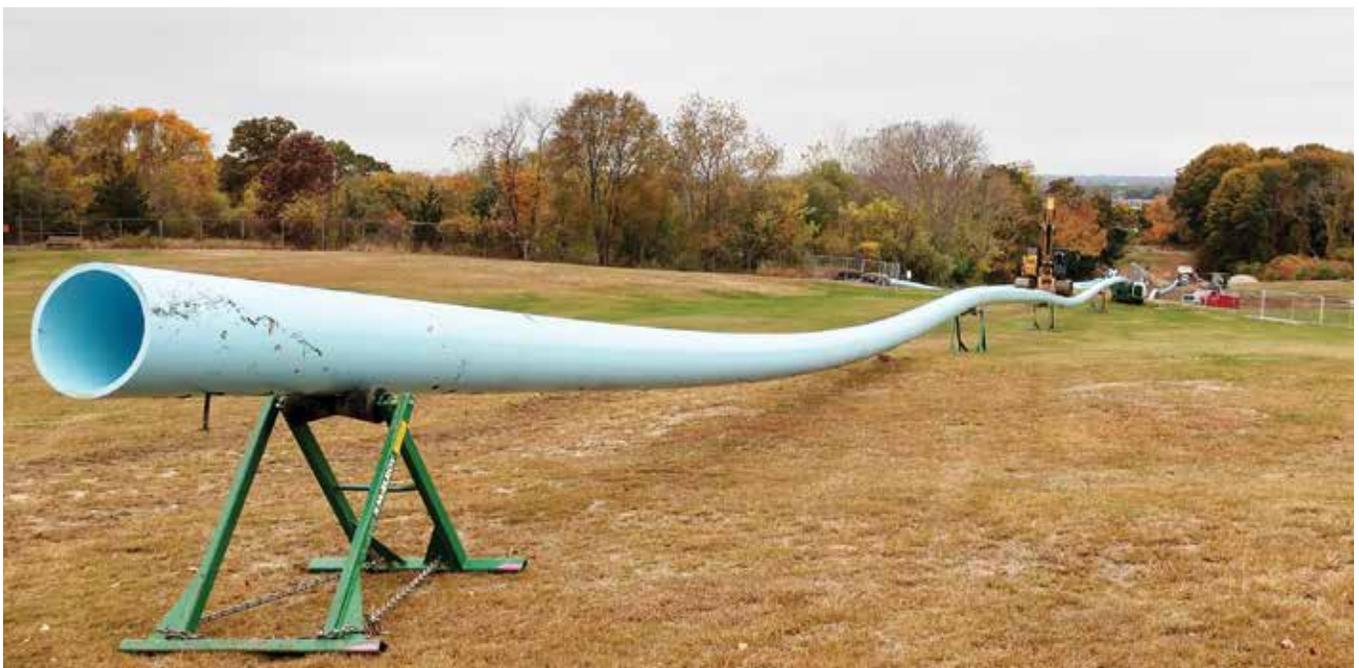
*PVC was fused into 450-foot lengths, 10 sections of pipe in total*
