North American Society for Trenchless Technology (NASTT) No-Dig Show 2010

Paper D-1-04

COLD WEATHER INSTALLATION OF FUSIBLE PVC USING HORIZONTAL DIRECTIONAL DRILLING

Lisa Lim¹, Arbind Mainali¹, Leo Rodrigue² and Randall Sonnenberg³

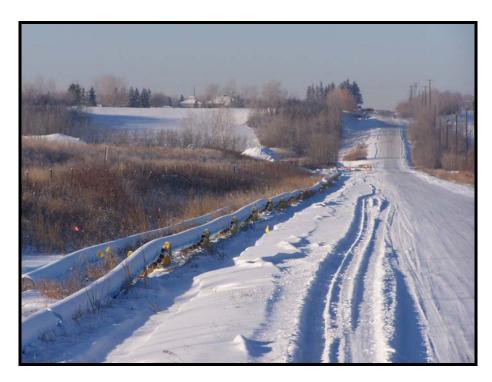
Figure 2. 153 Ave NE Road Right of Way Showing Fused PVC Pipe on Rollers

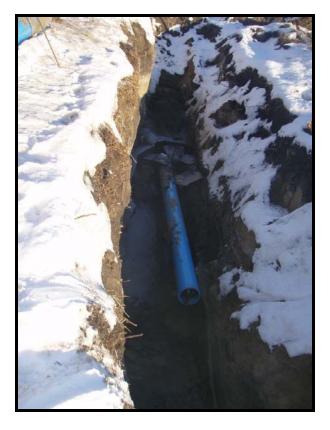
Figure 3. Construction in Mid-January

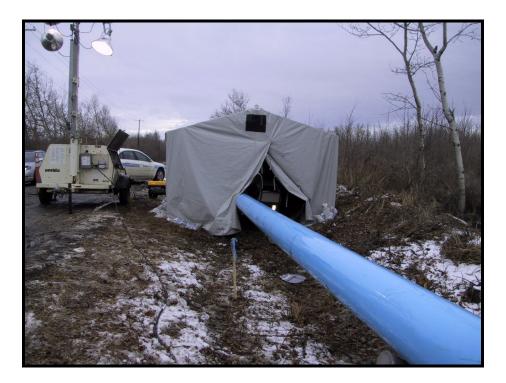
fusion process was setting up heated tenting using kerosene heaters and providing monitoring equipment to achieve a constant state for the 10 days that would be required for the fusion of the pipe to be completed. Figure 4 shows the fusion tent set up in the road right of way.

Figure 4. OLQP Fusion Tent

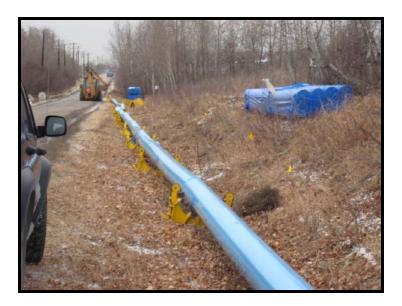
Figure 5. Rollers Used for Pullback Operations

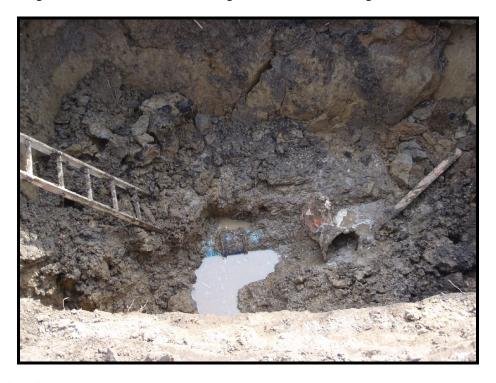
Many of the issues that occurred over the course of the OLQP project were related to the installation of valves subsequent to the installation of the pipe. During the design stage of OLQP, clear guidance on the need for mechanically restrained joints was not available and the design only called for mechanically restrained joints in areas of high potential movement such as steep grades. The majority of the valves installed were connected back to the pipe by Hymax couplings and thrust restrained with concrete thrust blocks. The problems were not apparent during the time of installation; however, during the pressure testing process, it there was leaking at a number of the valves installed. Figure 6 shows one of the valves along 153 Ave that was leaking.

Figure 6. Leaky valve at 153 Ave NE

The initialization of the water pressure during testing caused a water hammer effect where the surge caused the pipe to deflect or move away from the valve assembly. PVC has less ability to resist water hammer when compared to the more flexible HDPE. There is significant reduction in the intense initial pressure surge but the working pressure rating of the pipe is lower than the pressure being experienced at the time (Ricky, A. Ponder, 2006).

Because the valve assembly and the pipe are different materials, the potential for differential pressure is greater than in a situation where equivalent materials are connected. Another factor that may have caused leakage at the valve locations was that the reamer hole was approximately 1.5 times the diameter of the pipe, allowing more movement lengthwise in comparison to an open cut installation where the pipe would be completely backfilled. In an HDPE installation, mechanical restraints are required, however, in a fusible PVC pipe installation, information was not readily available to aid in the design and construction of the appurtenances.

Pressure testing for OLQP was estimated to take place over a period of 4-5 days. Due to the issues encountered with the valve restraints, testing occurred over a period of 10-11 days. This delay impacted the project by escalated costs for time, material and labour for increased testing. The resolution was to mechanically restrain the valves with Ford Meter Box restrainers.
