North American Society for Trenchless
Technology (NASTT)
NASTT's 2015 No-Dig Show

TM1-T5-02

Morgan County Quality Water District – Water Main Flood Damage Repair Project

Nathan Ferguson, Farnsworth Group, Inc., Fort Collins, Colorado
Steve Austin, Underground Solutions, Inc., Broomfield, Colorado
Mark Kokes, Morgan County Quality Water District, Fort Morgan, Colorado

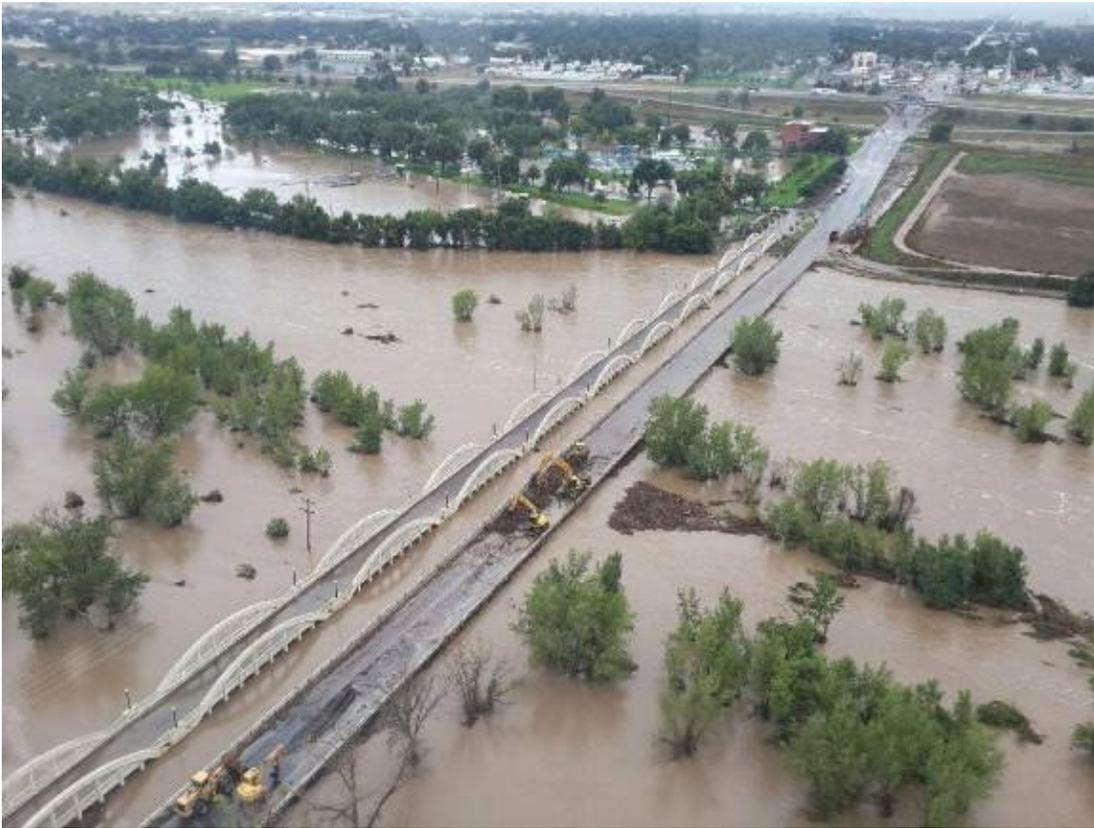
Figure 1. Flood waters overtake the established riverbanks in Morgan County, CO.

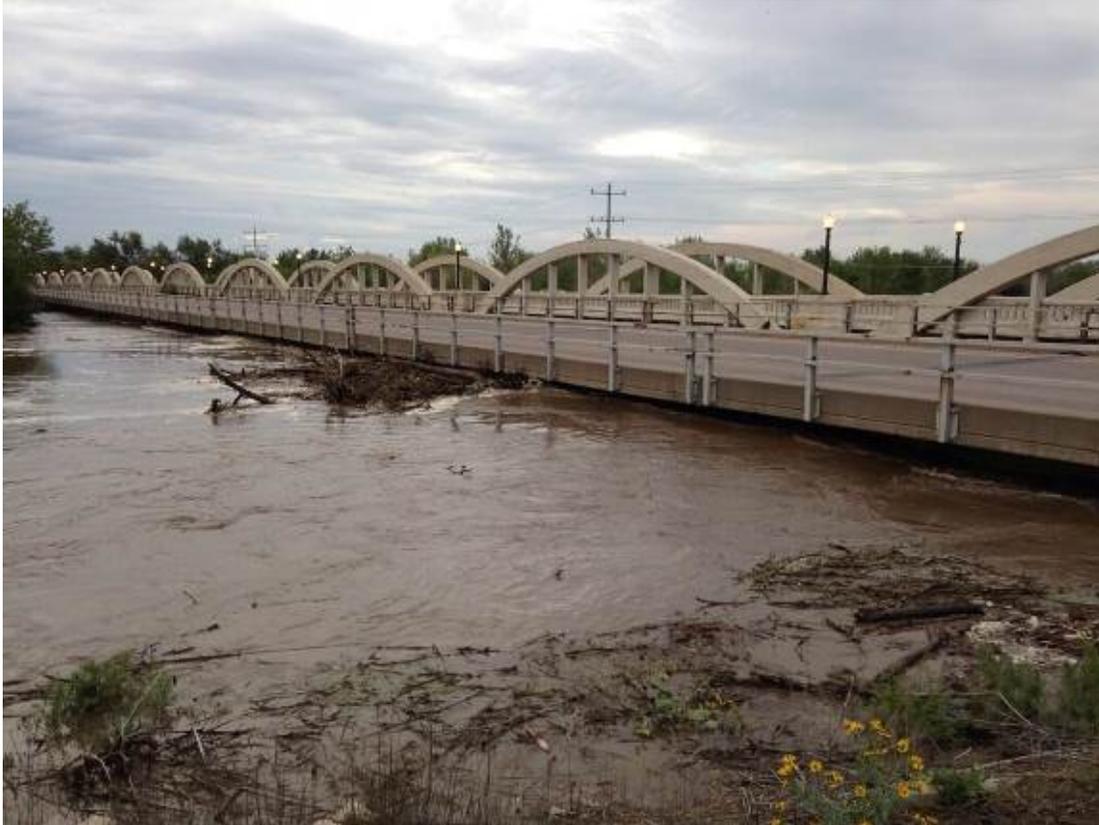
Figure 2. Flood waters nearly overcome a bridge crossing in Fort Morgan, CO, located in Morgan County.

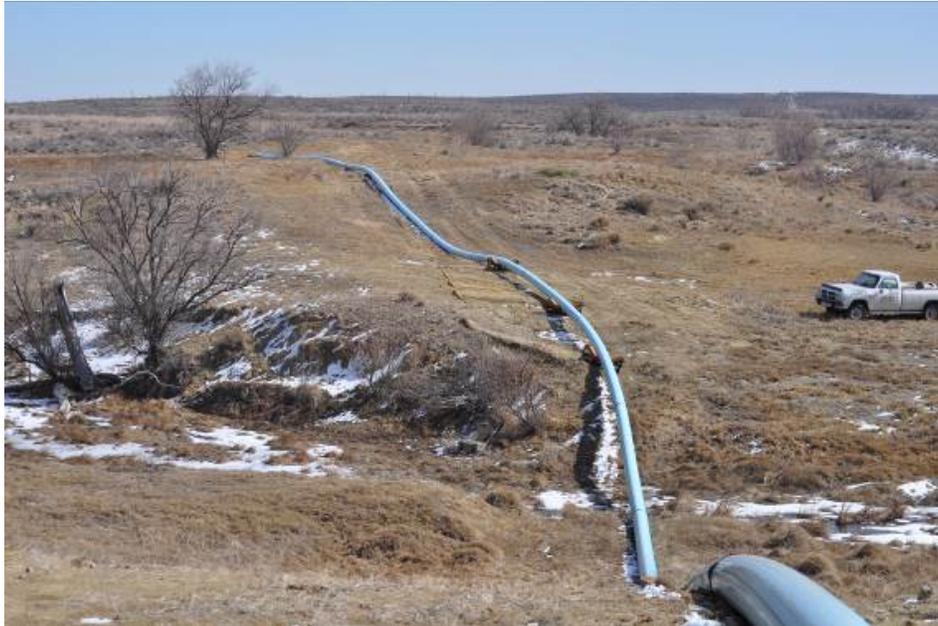
Figure 3. Laydown area for North Tank Crossing showing the staged pipe string alignment.

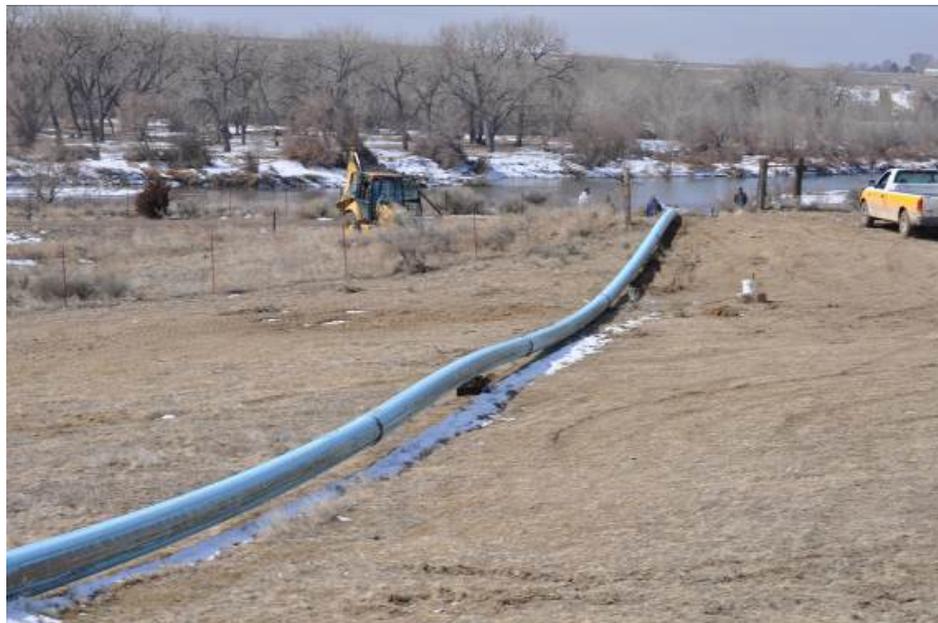
Figure 4. Front end of pipe string aligned with the insertion point towards the water's edge.

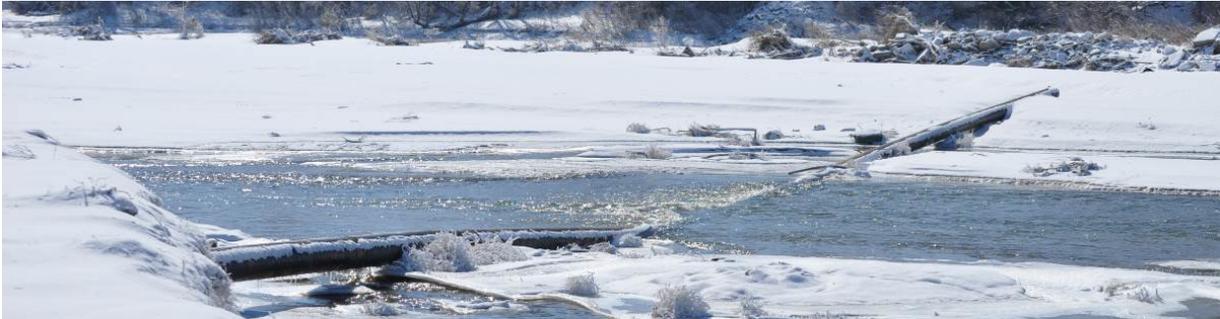
Figure 5. Exposed water main at Log Lane as damaged in the flood, shown after the flood waters had subsided.

The design process followed normal procedures including topographic survey of the crossing that was partially hampered by high South Platte River flows at the time of the survey. From the survey, a new alignment was identified to be off-set from the existing line which accommodated HDD working areas, pipe fusing operations, and tie-ins to the existing waterline (see Figure 6). Farnsworth designed the bore path to be a U-shaped profile with smooth transitions and curves well above the 275 foot minimum allowable bending radius of the 12-inch FPVCP. The profile of the pipeline was designed to maintain a minimum depth below the existing river bottom of 30 feet which resulted in a proposed bore of approximately 1,900 LF. As with the emergency North Tank Crossing, overall project schedule duration was reduced by the use of historical well information for soil conditions in the area. This information revealed similar soil conditions with poorly graded sands and gravels near the surface as well as a shale formation.

With an acceptable alignment selected, design calculations were completed to confirm the 12-inch FPVCP that MCQWD had purchased at the same time as the North Tank Crossing project would withstand the calculated pull force for the design alignment, depth and anticipated soil conditions. These calculations followed ASTM F1962-11 (ASTM, 2011) guidance and was found to provide adequate capacity for the crossing. To complete the design, waterline filling, testing and disinfection factors were considered and incorporated into the tie-in locations.

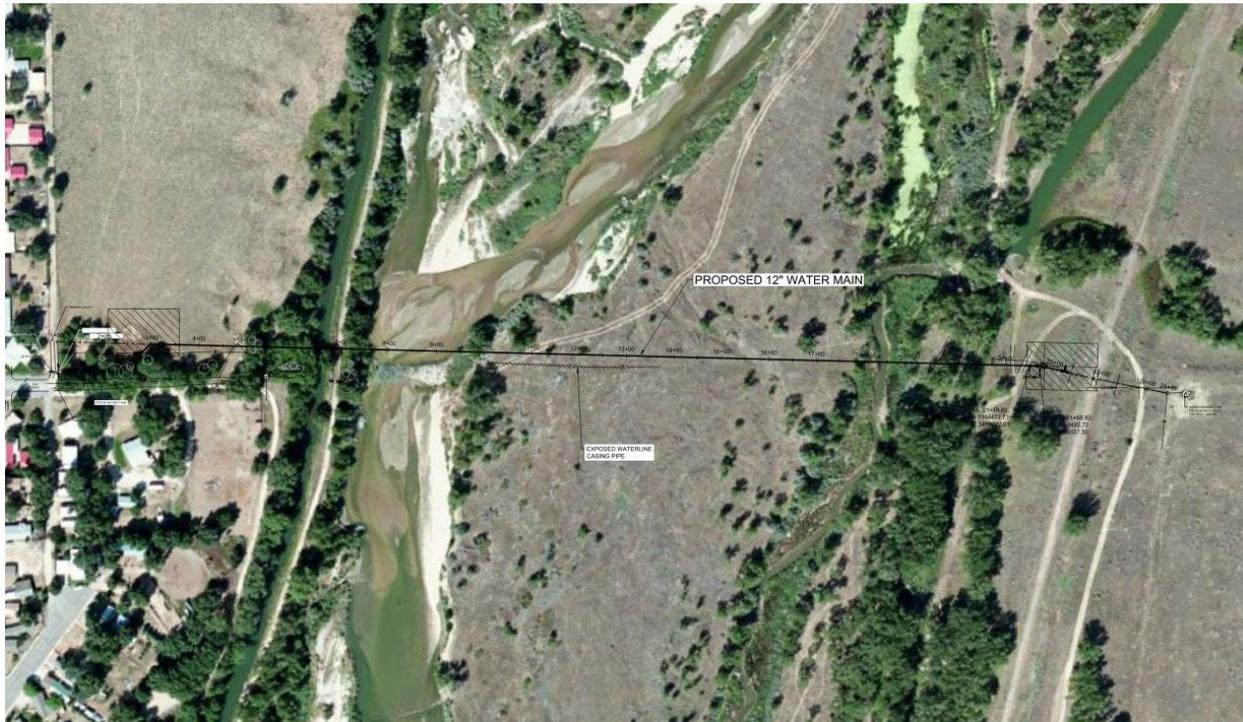
Figure 6. Log Lane Village Crossing Plan, shown schematically.

Unlike the North Tank Crossing, gravel at the surface was not an issue and pilot hole work was completed in relatively short order. As with all HDD applications, accurate pilot hole information is critical to the process and dictates the final alignment of the bore hole and pipe. Accurate steering can be made more difficult with river crossings depending on the technology used. This was the case at Log Lane as during the month of March, river flows required that a section of the bore hole could not be recorded. While Kleven continued with back reaming operations, pilot hole as-built information was being analyzed for conformance with the contract documents. Review by the Farnsworth found a potential area of concern in which the as-built profile deviated from the required profile. This issue appeared to be a "hump" or high point in the profile creating a location of potential increased pull forces during installation and an unplanned high point in the final pipeline. Further investigation found this location to be at the area of missing

information under the high flow sections of the crossing. This information was immediately communicated to the contractor and a meeting was held to review the issue.

While Klevin Construction understood the concern with the as-built profile, they were confident that a good bore hole existed based on the pull forces experienced during the back reaming process. To ensure an acceptable profile, it was decided that a new as-built of the bore would be performed. This as-built was completed at a time when other work along the South Platte River had diverted the flows to the south portion of the river allowing for as-built information to be recorded in the previously missed section. Immediate review of the new as-built proved that while the profile did gain elevation then flatten, no actual “hump” existed in the profile. Based on this analysis, the bore was approved for pipe installation.
