**North American Society for Trenchless Technology (NASTT)
NASTT's 2016 No-Dig Show**

**TA-T6-04
Slipline Method Used to Repair
a Leaking Pipeline Installed with HDD**

Richard Delp, Baskerville-Donovan, Inc., Pensacola, FL
William (Phil) Phillips, Municipal Engineering Services, Inc., Navarre, FL
June Baterina, Underground Solutions, Inc., Poway, CA

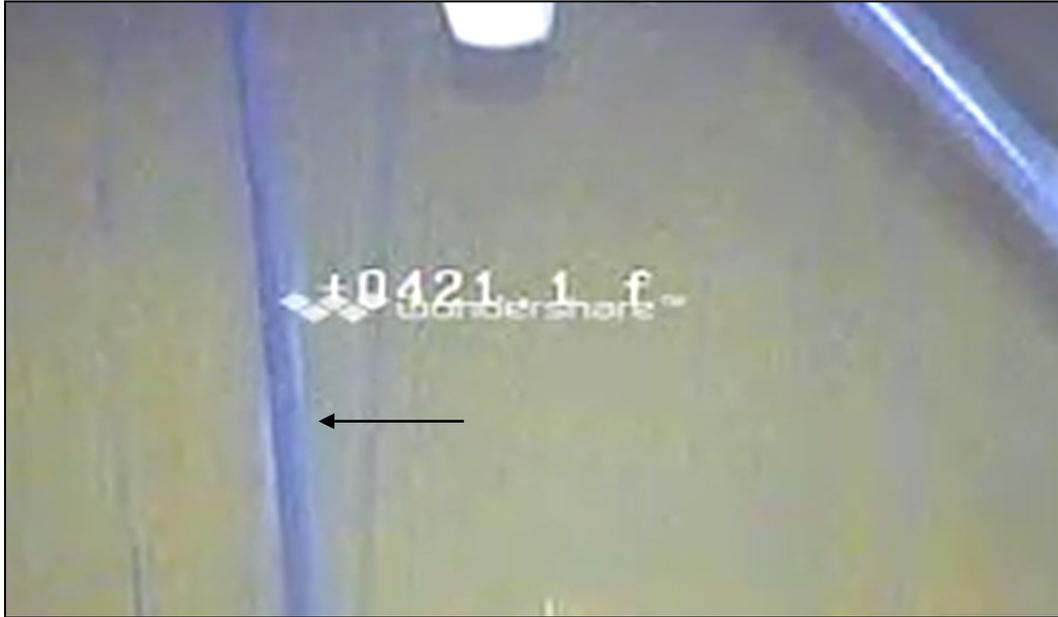
Utility Service successfully passed the anchor buoy through the existing pipeline and very little sand was observed ahead of the buoy when it exited. A 1/16" steel cable was pulled through the pipe behind the buoy. Using the cable, Griner Drilling pulled a larger diameter nylon rope through the pipe, a line that would hold against greater pulling pressures. At 408-feet into the camera pull, a fracture in the pipe wall was discovered. The longitudinal fracture was traced and observed for approximately 13 feet and was located between thermal butt-fusion joints used to assemble the pipe (See Figures 3 and 4). With no internal pressure on the pipeline except the static head of water in the line, no infiltration was observed of existing surrounding soil or debris coming [n3] into the pipeline from the exterior of the line. At the point of the leak, the depth of the bay to the surface of the ocean floor, or mudline, [n4] was approximately 15 feet, and the pipeline was located 65 feet below the mudline for a total of 80 feet of cover over the area of the failure.

Figure 3. Freeze frame of the video inspection showing the fracture roughly at its midway point.

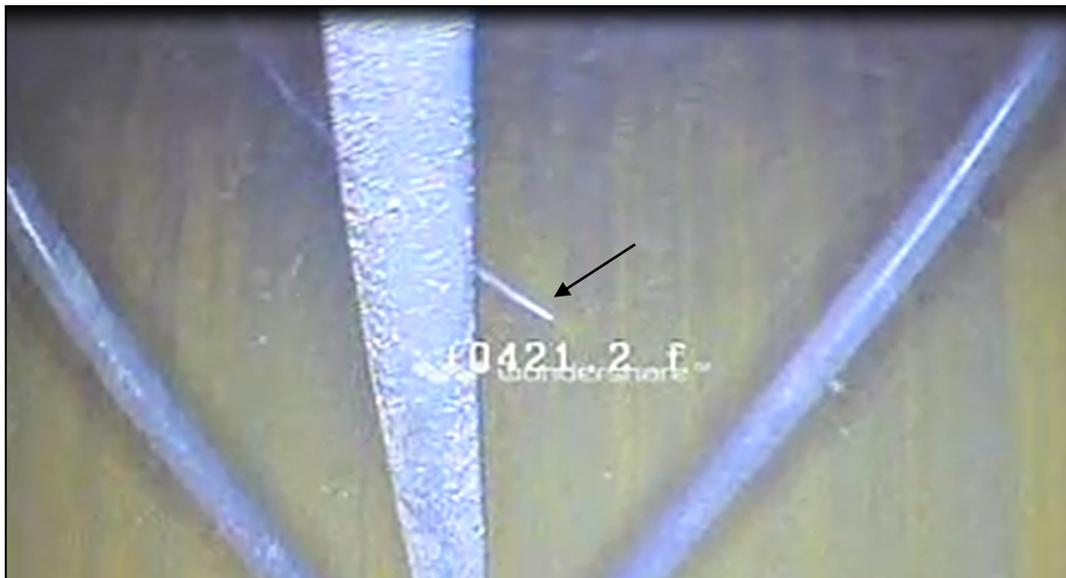
Figure 4. Freeze frame of the video inspection showing one end of the fracture.
