Pipe-Bursting Challenges Provide Valuable Lessons

Problems surrounding the rehabilitation of a leak-prone water transmission pipeline were solved through cooperation and hard work. In the process, the city of St. Helena, Calif., gained valuable insights for future projects. **BY COLLINS ORTON**

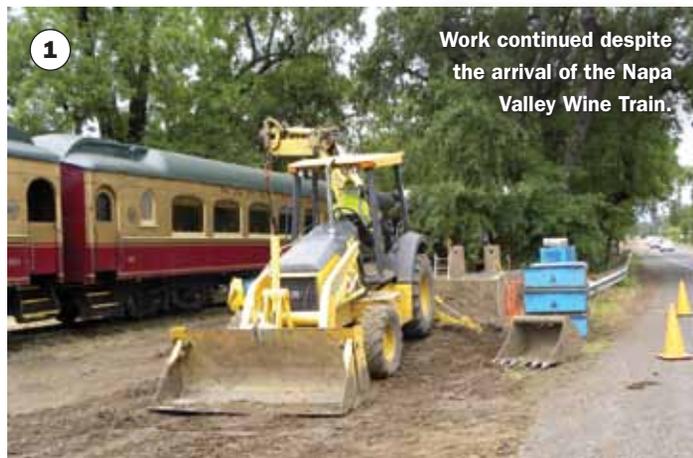
1

an open trench, a costly undertaking that would encroach onto California Highway 29. The California Department of Transportation wasn't interested in impeding traffic in the area. The existing alignment is located in a narrow right-of-way between heavily traveled Highway 29 and the railroad used by the Napa Valley Wine Train (Figure 1).

Work continued despite the arrival of the Napa Valley Wine Train.

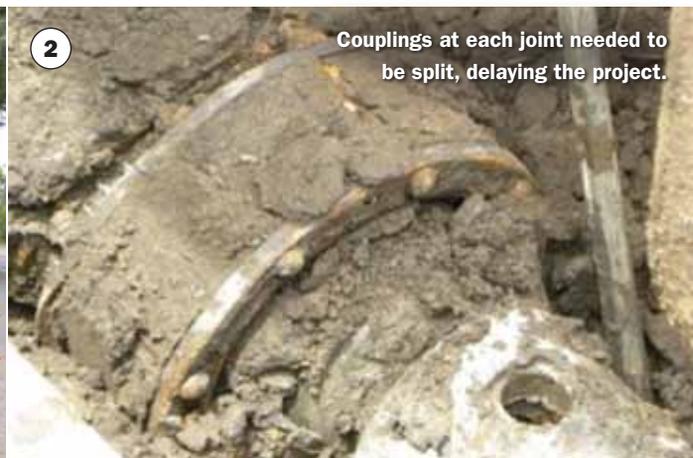
2

Couplings at each joint needed to be split, delaying the project.

The pipe was launched, but the bursting and splitting operation didn’t proceed as planned. Although the WSP was split, progress was stopped in the first 40 ft because of the couplings, requiring the contractor to dig up each coupling to proceed. With only 120 ft of progress made during the next three days, additional technical support was needed. The couplings at each joint required the pipe-splitting system to split the steel pipe and the couplings (Figure 2).

The couplings added several inches to the pipe’s diameter. The contractor contacted the trenchless equipment manufacturer to determine if the pipe and couplings could be split and to explore other options. The contractor

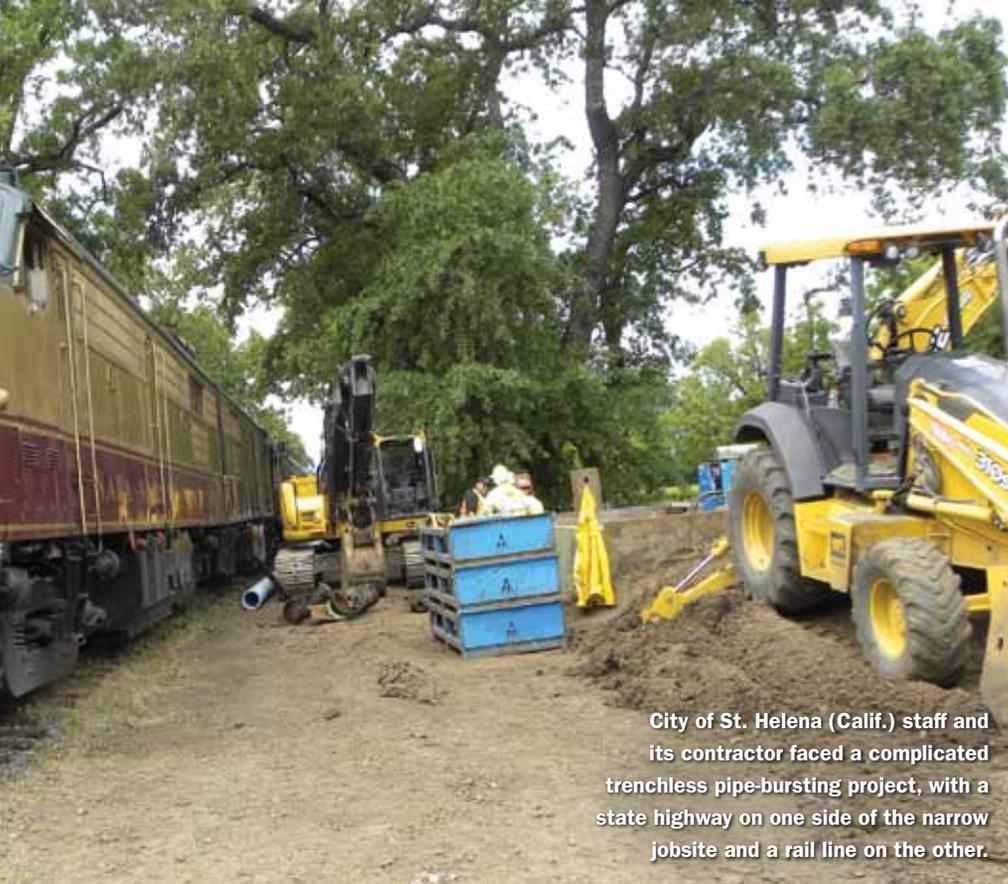
City of St. Helena (Calif.) staff and its contractor faced a complicated trenchless pipe-bursting project, with a state highway on one side of the narrow jobsite and a rail line on the other.

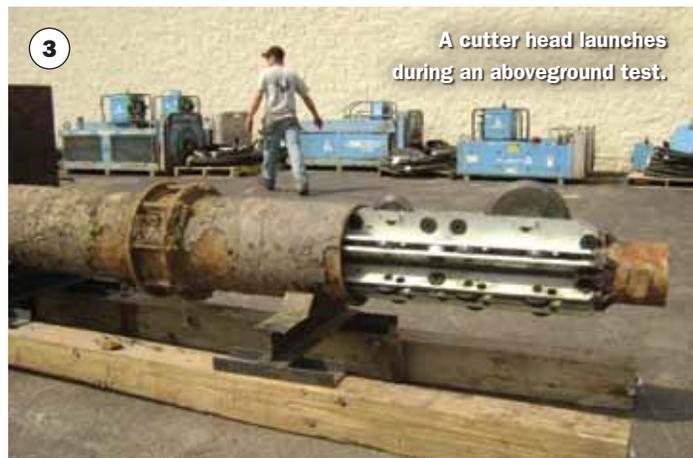
3

and manufacturer decided it was best to excavate, remove, and ship to the manufacturer a 10-ft section of WSP with a coupling for aboveground testing. Figures 3–5 illustrate how the pipe and couplings were split. A static-bursting machine was used for testing and subsequently for the project. The manufacturer confirmed that the burst test was successful. After viewing videos of the tests, the contractor proposed a new bursting procedure.

A cutter head launches during an aboveground test.

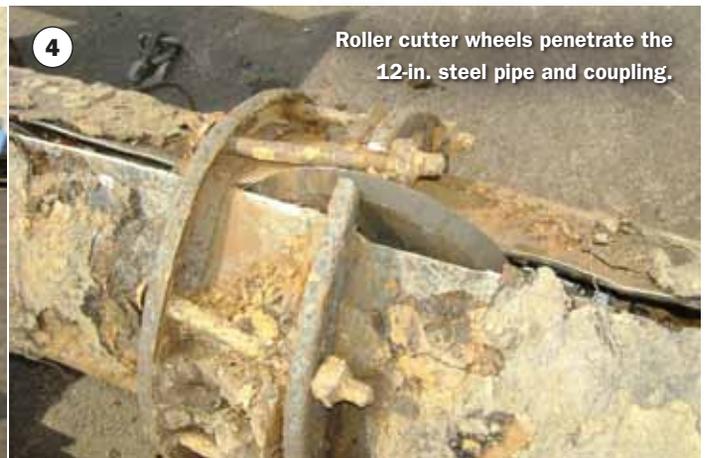
4

Roller cutter wheels penetrate the 12-in. steel pipe and coupling.
