Waste Activated Sludge Pipeline Rehabilitation:

14,000 Linear Feet of Slip Lined Fusible PVC®

By: Marvin Lee, AEGION

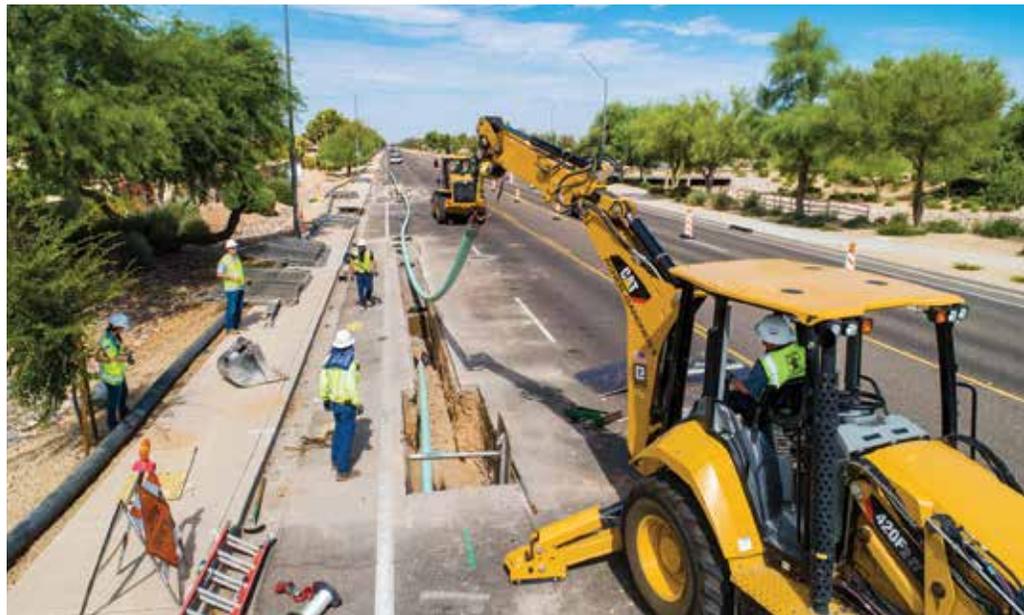
Majority of 13 installs were over 1,000 feet, longest was 2,300 feet

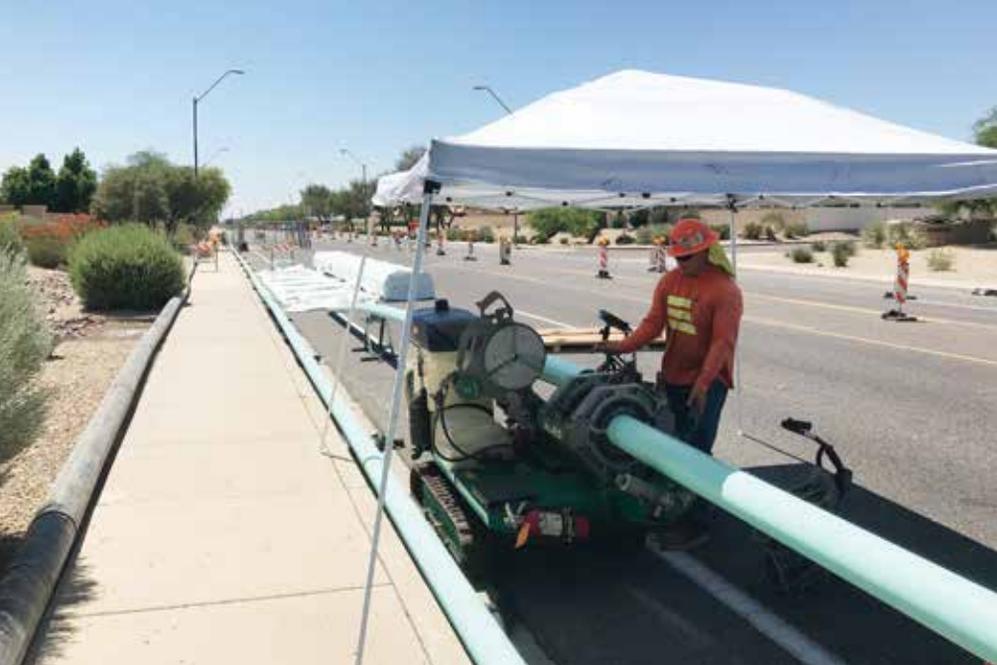
FPVCP was fused on the street surface in a closed lane. The 110°F days were a challenge

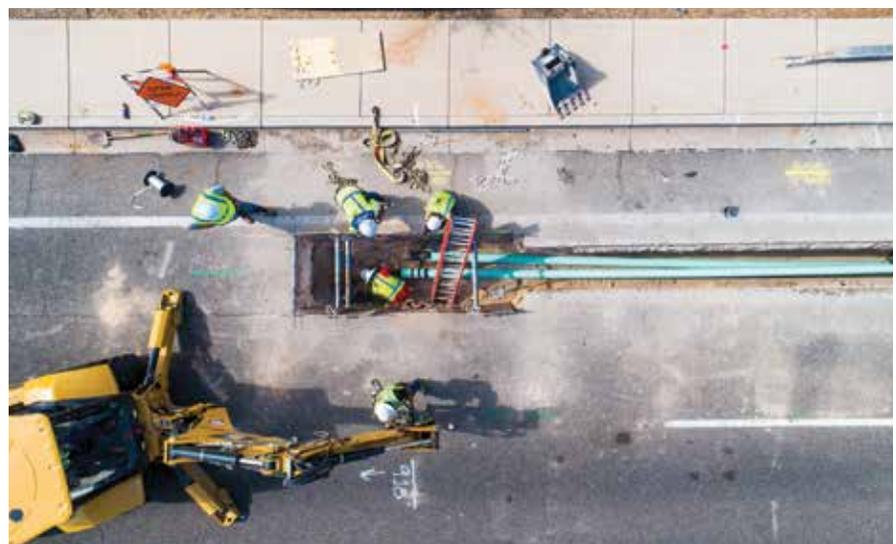
Compact site: 4x13-foot pits with a 40-foot long tail ditch were used
