Sliplining Rehabilitates Critical Water Supply Line

It's tough to imagine a more difficult job than rehabilitating a water pipeline passing 25 ft beneath an interstate highway bordered with steep embankments in a busy tourist area, but that's what the Las Vegas Valley Water District faced. **BY JIM FORCE**

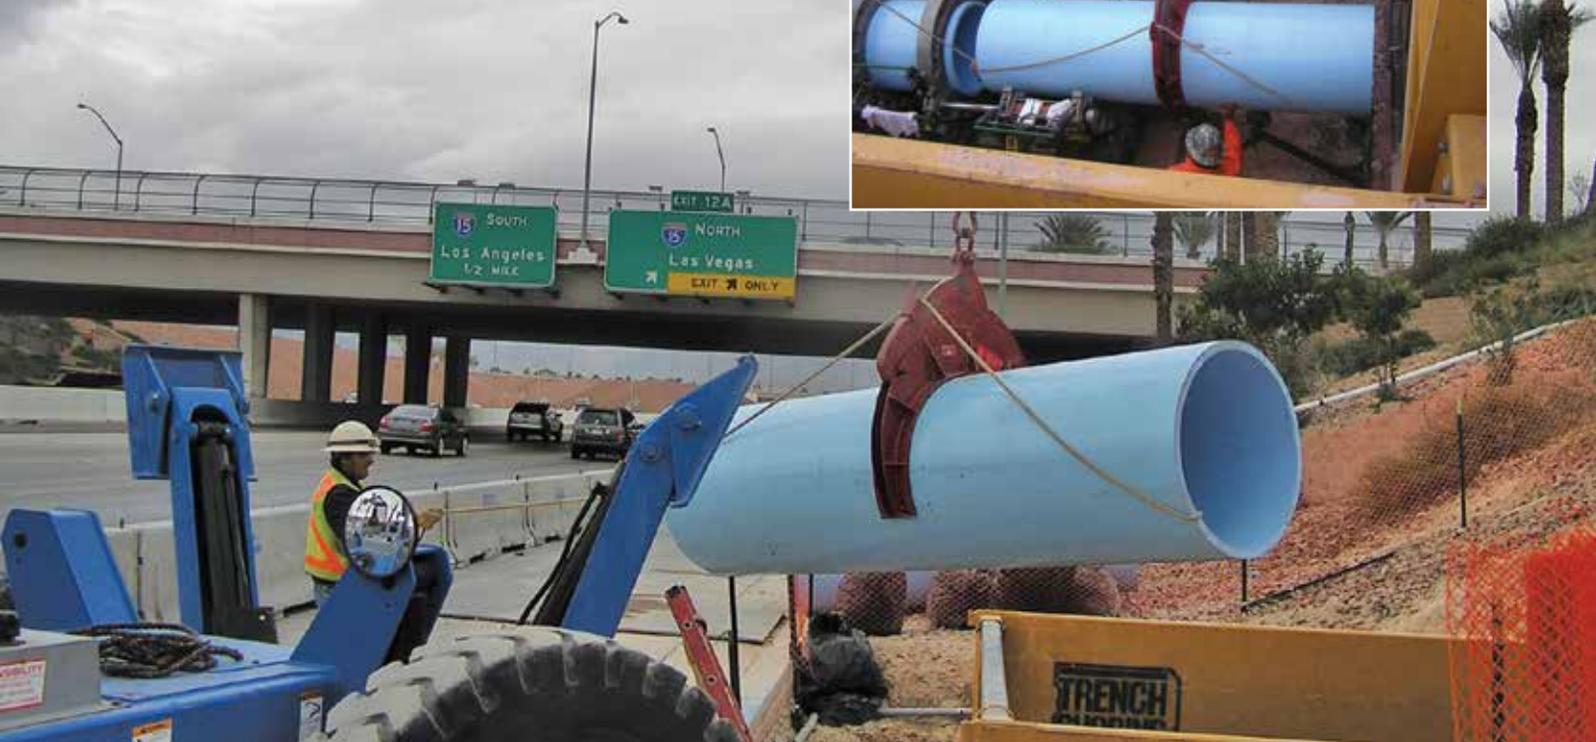
For challenging pipeline alignment such as the I-215 project, sliplining with FPVC proved to be a feasible, cost-effective alternative to more disruptive methods. In-pit fusion of 10-ft pipe sticks was used to restore the section of pipe directly below the highway (inset).

Because of the highly constrained work area adjacent to I-215, in-pit fusion

of 10-ft pipe sticks was used to restore the section of pipe directly below the highway. Although FPVC is usually supplied in 40-ft lengths, the manufacturer provided 10-ft pipe sections to accommodate the tight worksite. Standard ductile-iron fittings were used for the vertical offsets to facilitate connection to appurtenances and other pipe segments.
