**North American Society for Trenchless Technology (NASTT)  
NASTT's 2014 No-Dig Show**

**MA-T4-03**

**Cornplanter Township Installs New Water and Sewer Force Mains  
Using Combination of Trenchless Methods**

Joe Pacchioni, Herbert Rowland & Grubic, Inc., Hermitage, PA  
David Hechmer, Herbert Rowland & Grubic, Inc., Hermitage, PA  
June Baterina, Underground Solutions, Inc., Poway, CA

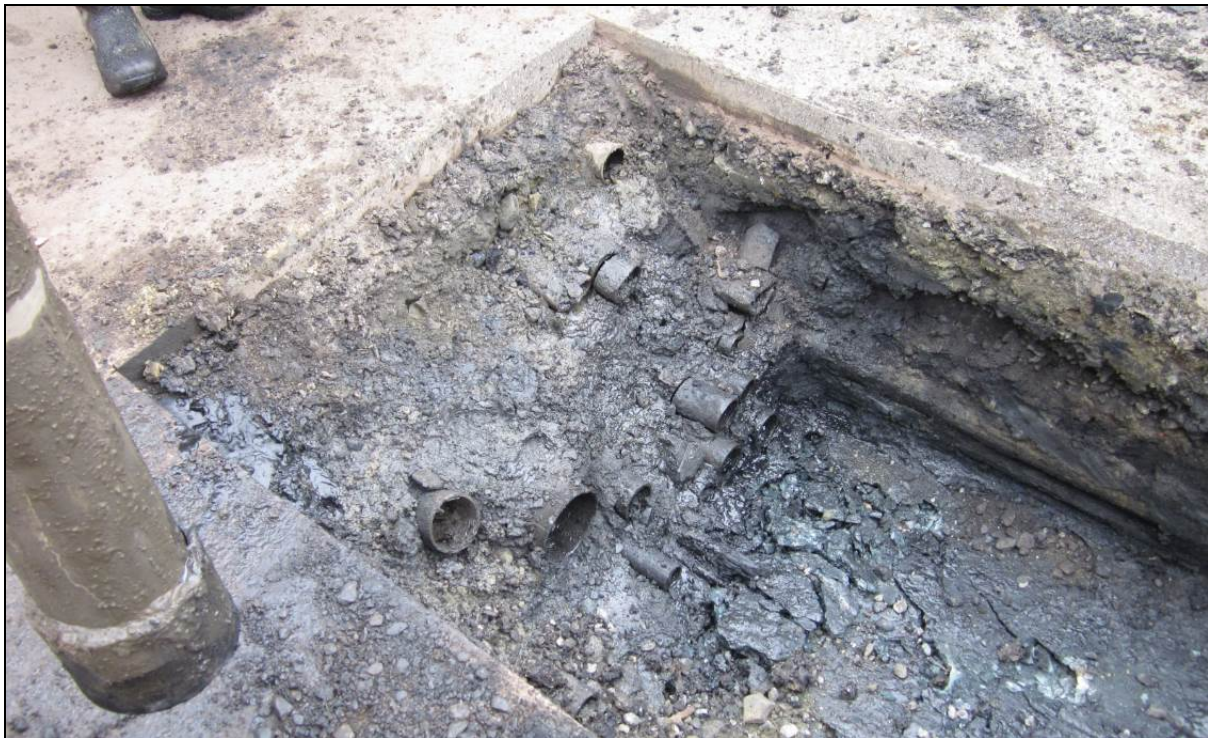
Figure 3. Explorative excavation showing contaminated soils and existing utilities, including a multitude of process lines.

Standard open trench excavation was considered problematic due to the known ground water and hydrocarbon contamination. Standard procedure required that the contaminated soils be taken from the project to be treated and disposed of as a hazardous waste at the local landfill. Existing conditions also had to be taken into account. There were various utilities throughout the project area that had been installed over the last 100+ years (see Figure 3). Of note were the 'process lines' that were used as part of the oil refinery and production processes. These process lines, due to the nature of the fluids they conveyed would greatly increase the cost of the project or at its worst cause a shut-down. The newly installed Pennsylvania Department of Transportation (PennDOT) storm sewer systems also caused concern for open trench installation.

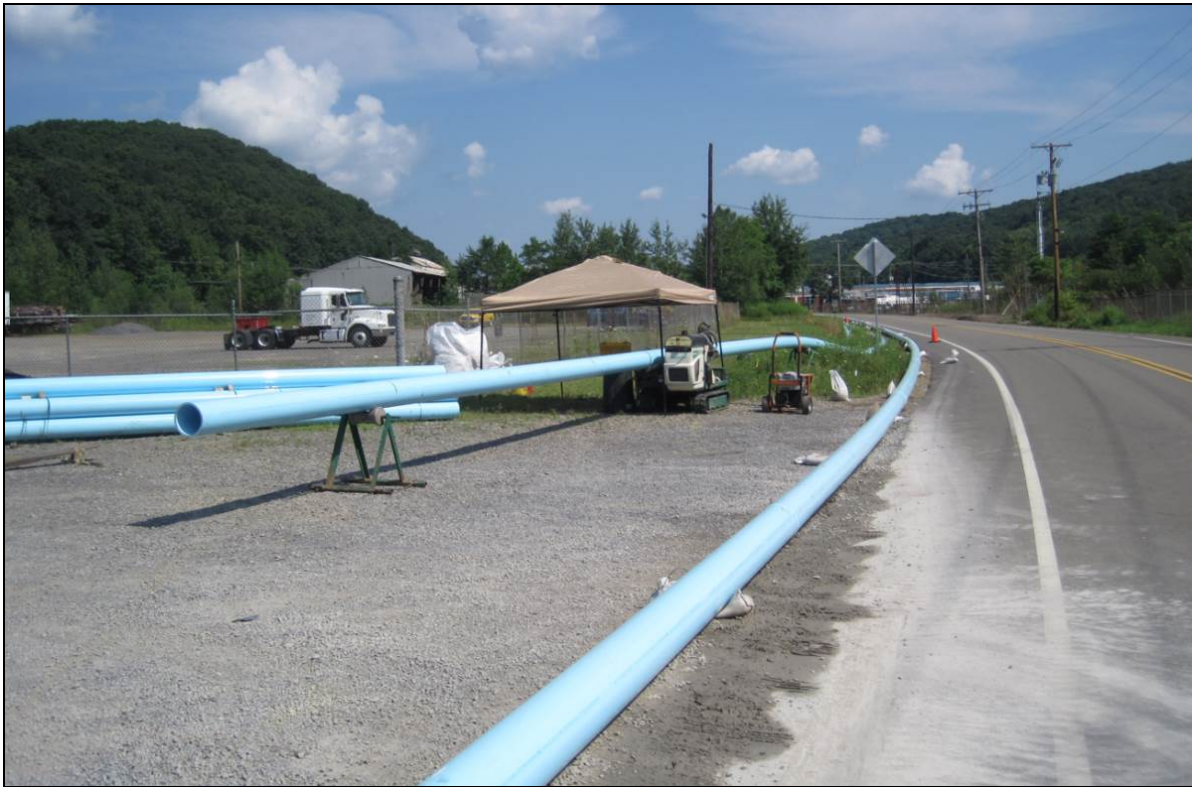
Figure 4. Fusion staging and assembly layout for the waterline to be installed using HDD methods.

Construction began in August, 2012 and the water line was installed first. The pipe laydown and staging areas were strategically placed along the road in order to minimize disruption for passing cars as well as the businesses in the vicinity. Figure 4 shows one of the pipe fusion and staging areas along State Route 8. In order to reduce the size of the HDD entry/exit pits, the contractor elevated the pipe using raised rollers. Known in the field as “abbreviated aerial entry”, this method allowed a steeper entry of the pipe which also reduced the amount of spoils to be disposed of when constructing the insertion pit (see Figure 5).

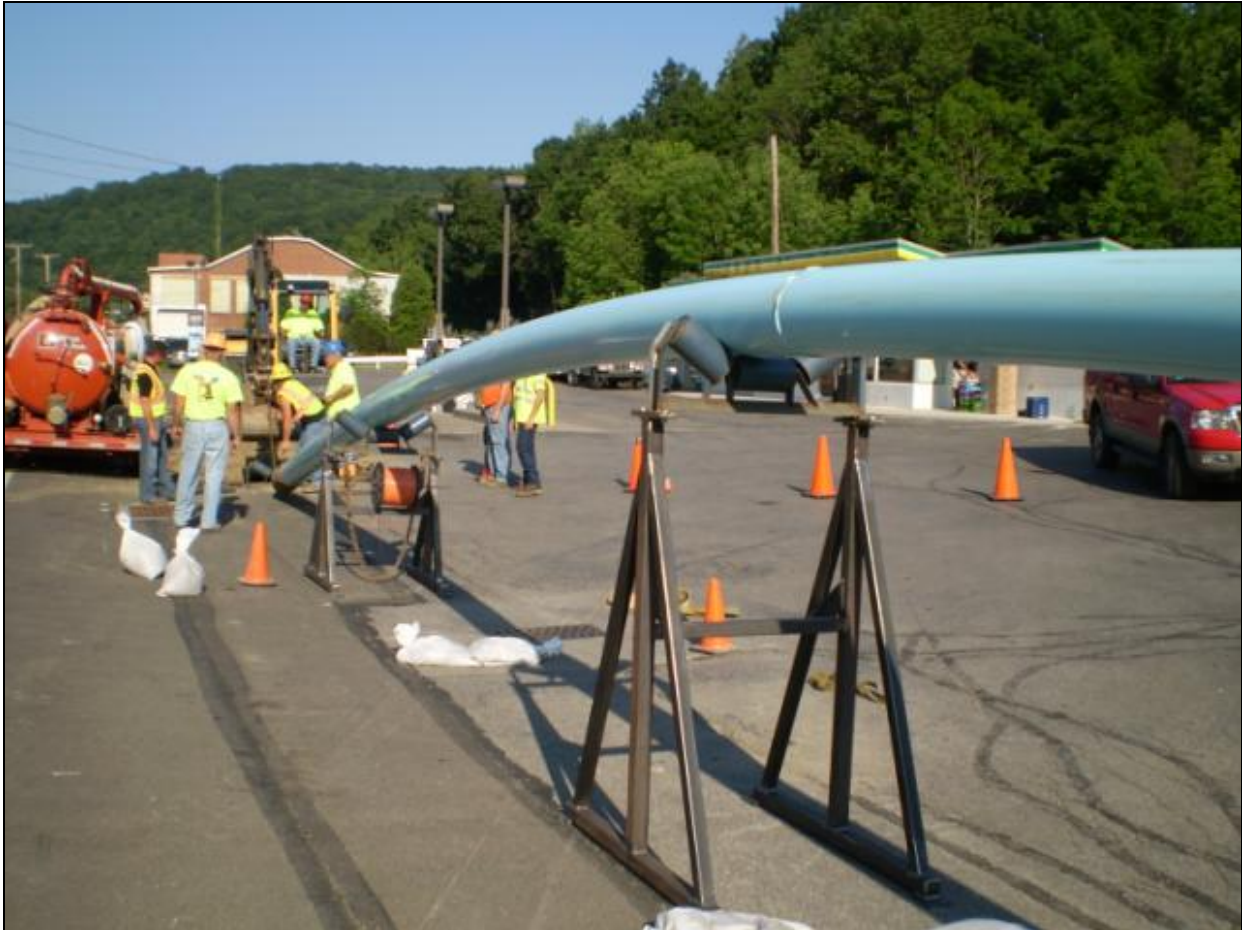
Figure 5. Typical insertion location for the HDD entry pit, illustrating the “abbreviated aerial entry” method.

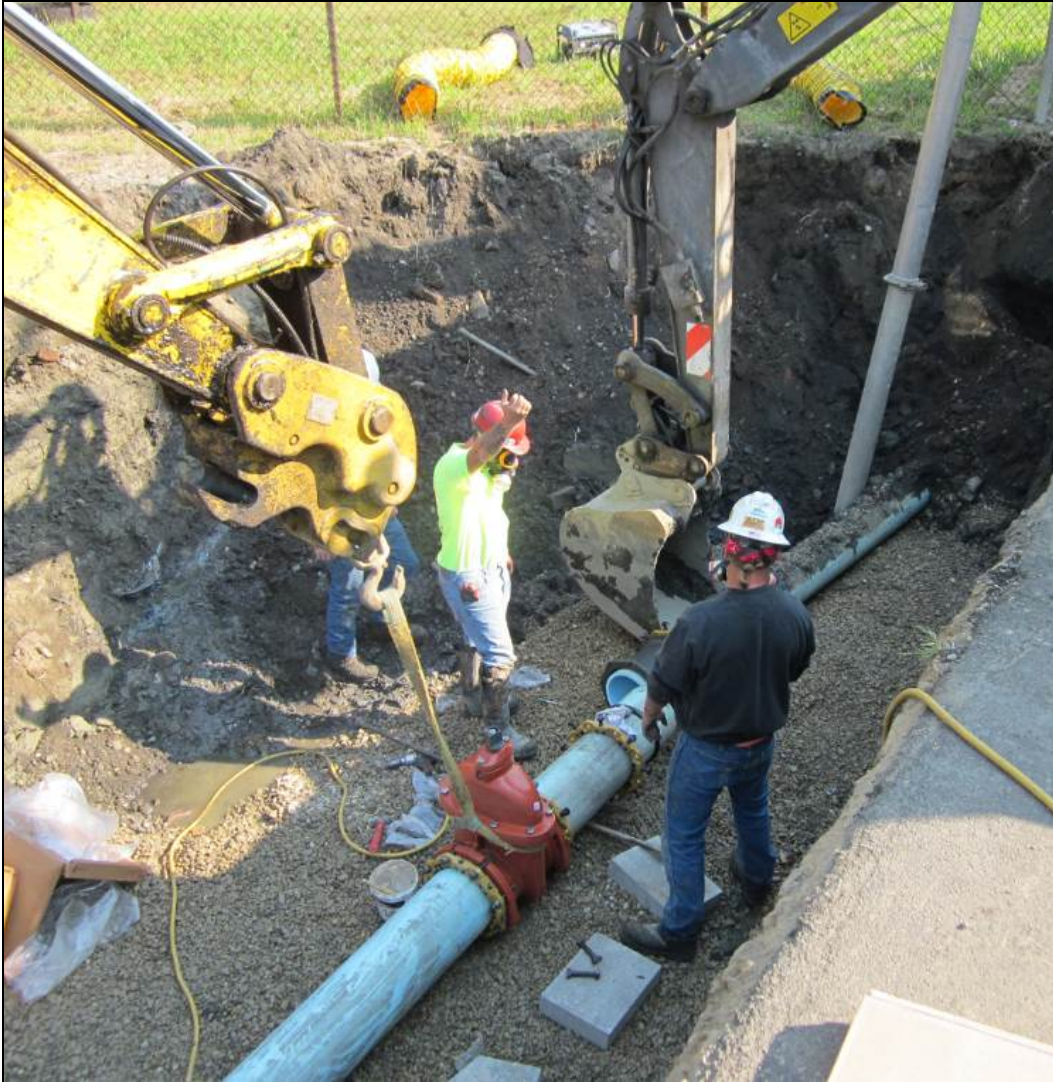
Figure 6. Typical fire hydrant installation and HDD pipe section tie in inside entry/exit pit location.

The entire 6,135 feet of the 10-inch FPVCP potable water main was installed with a total of nine drill sections of various lengths. A 12-inch reamer was used for the first drill section. The contractor first bored a pilot hole, then reamed with the 12-inch reamer size, and finally pulled the pipe back on the third pass. Although there were no major issues during the drill, the engineer required that the contractor use an 18-inch reamer for the remainder of the project. The contractor bored the pilot hole, then pulled back with the reamer and the pipe in a two-pass installation. Once the drill segments were installed, connections were completed in the installation pits. Figure 6 illustrates a tie-in of two HDD pipe sections along with a gate valve and fire hydrant, which was typical of these connection locations.

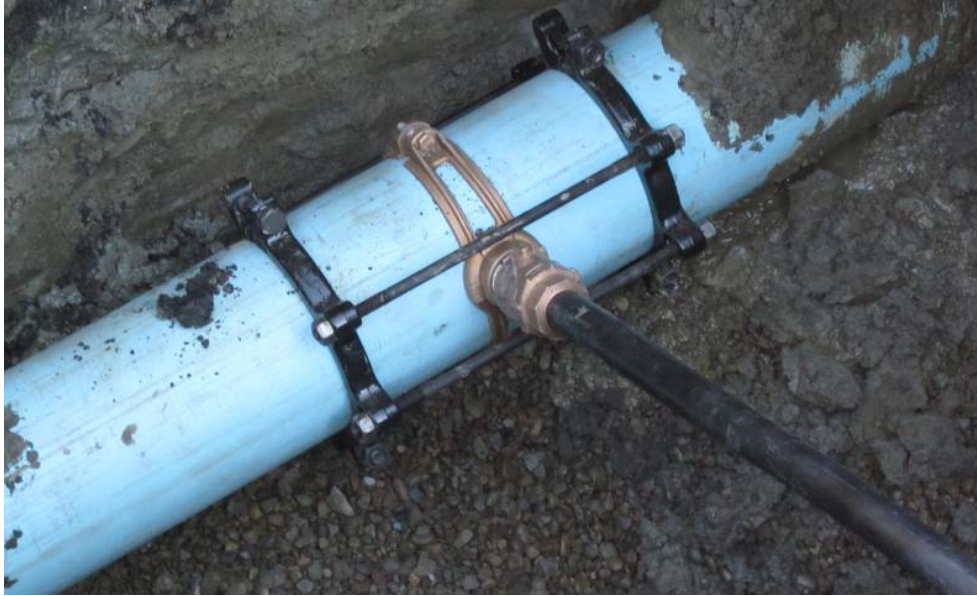
Figure 7. Service saddle installation showing the use of the bell restraint harnesses for axial stress management at the tap location.

Once the waterline was completely installed, service saddles were installed along the main. A total of twenty-three 2-inch service taps were installed while the water main was under a static pressure of 135 psi. Figure 7 shows a completed service saddle installation. For this size of waterline, a 2-inch service for FPVCP requires some means to reduce or eliminate the axial stress that is imparted on the pipe during installation. To do this, the design called for bell restraint harnesses to distribute axial stress across the tapping saddle and the location of the tap.

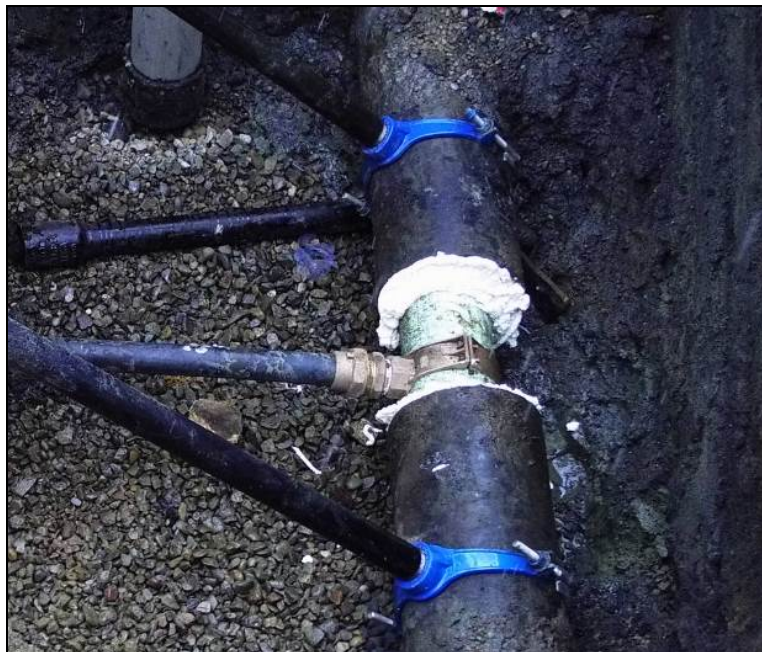
Figure 8. Typical service saddle connection on 6-inch force main and grout venting lines on existing cast iron line.

After the pipe was pulled into place, sections of the existing cast iron line were removed and lateral service saddle connections were installed. Taps and saddles were installed on the 10-inch cast iron line for the purpose of venting during the grout installation. Flowable grout was then pumped through the annular space, and the vent lines were removed prior to closing the pits. Figure 8 shows the installation of the lateral service saddle and grout venting lines.
