**North American Society for Trenchless Technology (NASTT)
NASTT's 2015 No-Dig Show**

**Paper MA-T4-04
Six Miles of Fusible PVC® Pipe Used to Rehabilitate Water Line
in Rural Wyoming via Trenchless Construction**

Willie Bridges, Pryor Mountain Engineering, Cowley, WY
Jason Spielman, Mountain View Building, Sheridan, WY
June Baterina, Underground Solutions, Poway, CA
Pat Laidlaw, Underground Solutions, Poway, CA

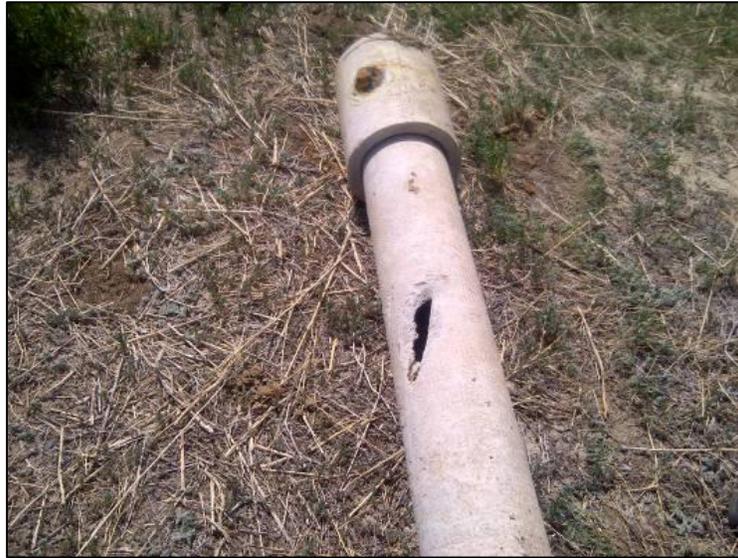
Figure 2. Longitudinal crack along the 6 inch AC pipe.

For the past 50 years, the main waterline serving the town of Cowley was a 6-inch asbestos cement (AC) line. Constructed in 1962, this line reached a total of roughly 6 miles along Highway 310. Given the age of the AC line, leaks throughout the line were intensifying, and the town's primary source of water was failing. In most recent years, from 2007 on, there were roughly 2 to 3 major breaks that took place along the line per year. In addition, the breaks that occurred showed longitudinal cracks along the pipeline, which made pipe rehabilitation much more challenging and costly (See Figure 2). Once a section of cracked pipe was exposed, repairs would result in removing and replacing a larger section of pipe than initially planned. This resulted in unexpected incurred costs to the original project. Since the AC pipeline was evidently reaching the end of its lifespan, it was apparent that the line that served this high desert area needed to be replaced.

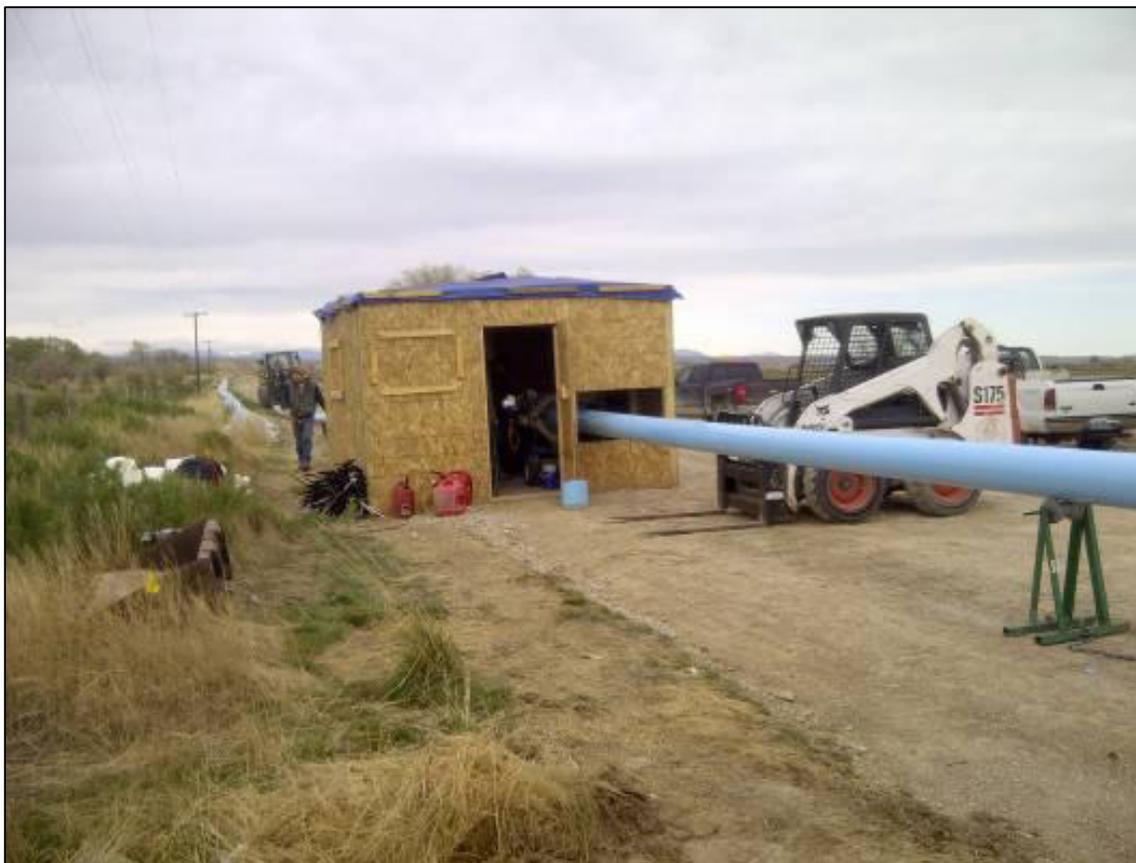
Figure 5. Fusion protection from Wyoming elements

Construction began in March of 2012, just after the winter season and at the start of crop season. Even though the winter season had come to an end, ambient temperatures were still low, which would nonetheless affect the cooling of pipe joints. In order to solve this issue, contractors positioned sheds along the project area to protect the pipe fusion process from the unsettling weather conditions (see Figure 5). Because the project area consisted of open farm fields, there was no concern of involving disturbance to passing cars or nearby business. The proposed waterline ran parallel to Highway 310, with a horizontal distance of approximately $\frac{1}{4}$ of a mile. So when it came to laying out the pipe before installation, and staging all other equipment, contractors mainly took into account the landowners and county roads closest to the project area, selecting vicinities that were the least intrusive. Fortunately, the nearby county roads that the proposed pipe crossed under were not disturbed because contractors were able to find pipe bursting pits around the roads, minimizing any type of excavation they would have had to do through the roads.

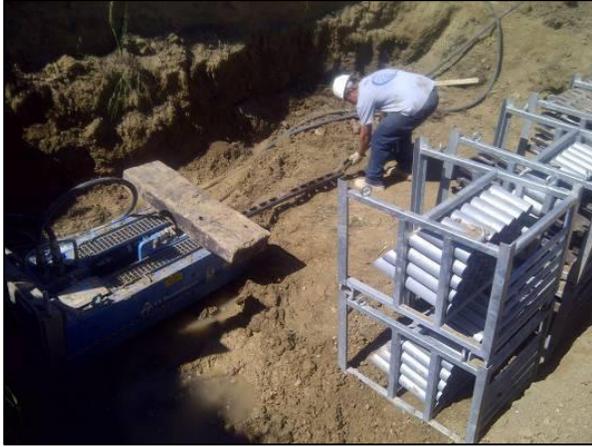
Figure 6. Insertion of pipe burst rods

The length of pipe that was installed via pipe bursting methods totaled roughly 16,000 linear feet. For the most part, fusion, layout, and installation were all accomplished successfully with no major setbacks. The soil conditions that once posed a concern for the contractors actually turned out to be an advantage for the crew. Because of the bentonite clay present in the area during crop season, this created a more lubricated enclosure for the pipe during pipe bursting pull-in. With most of the soil conditions remaining consistent throughout the project, the pipe burst installation for the most part was unproblematic. The last section of pipe that was burst turned out to be the most time consuming. Contractors noticed an increase in the pressure of the pipe bursting machine, which meant that the soil conditions in that area were not the same as that of the rest of the project. Because the soil was more compacted in this area, the pipe bursting installation took a little longer than expected. Another minor obstacle the crew faced during installation was that one of the fusion machines kept pausing, causing more delay in the project. Since the issues that took place during construction were so minor and minimal, time management was not a huge factor for contractors, as they stayed persistently ahead of schedule. One major breakthrough that Mountain View Building experienced during pull-in was a new record length for pipe bursting, with a measurement of 2,120 linear feet. With the actual pull-in lasting 3 to 4 hours, the total length of time, including set up and reconnection, took a total of 12 hours to complete, from start to finish. Figure 6 below illustrates the pipe burst rods being inserted into the existing pipe, and Figure 7 shows the 10-inch pull head on the Fusible PVC® pipe next to the 6-inch asbestos cement pipe.

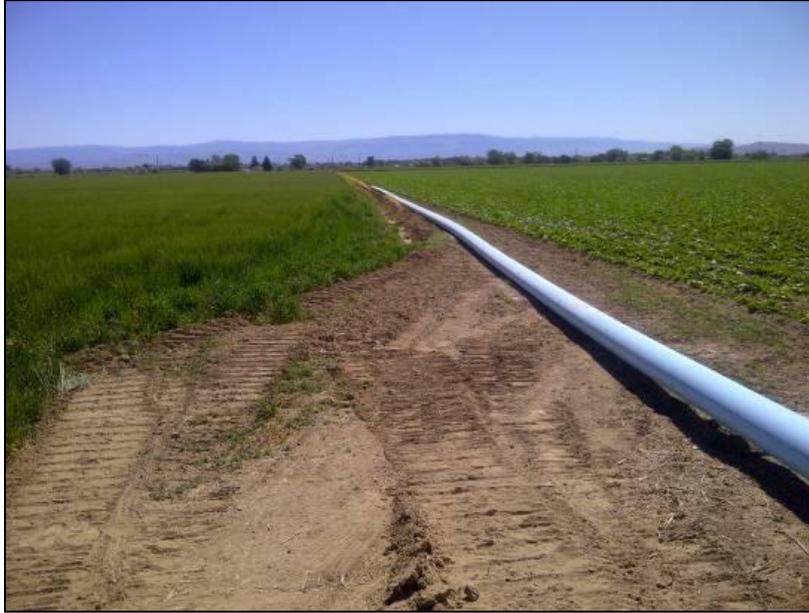
Figure 8. Pipe strung out in beet fields

While pipe bursting was taking place, another crew was appointed to complete the HDD segments of the project. Some of the HDD pipe sections were modified from the original design plans so that Fusible PVC® would be allowed to reach the minimum allowable radius. Figure 8 below shows the layout of the new pipe just before the HDD installation. Drill and reconnection of the pipe was completed with no drawbacks.
