**North American Society for Trenchless Technology (NASTT)
NASTT's 2018 No-Dig Show**

TM1-T2-02

**HDD Enables Florida Utility to Serve Popular Tourist
Location Without Interruption**

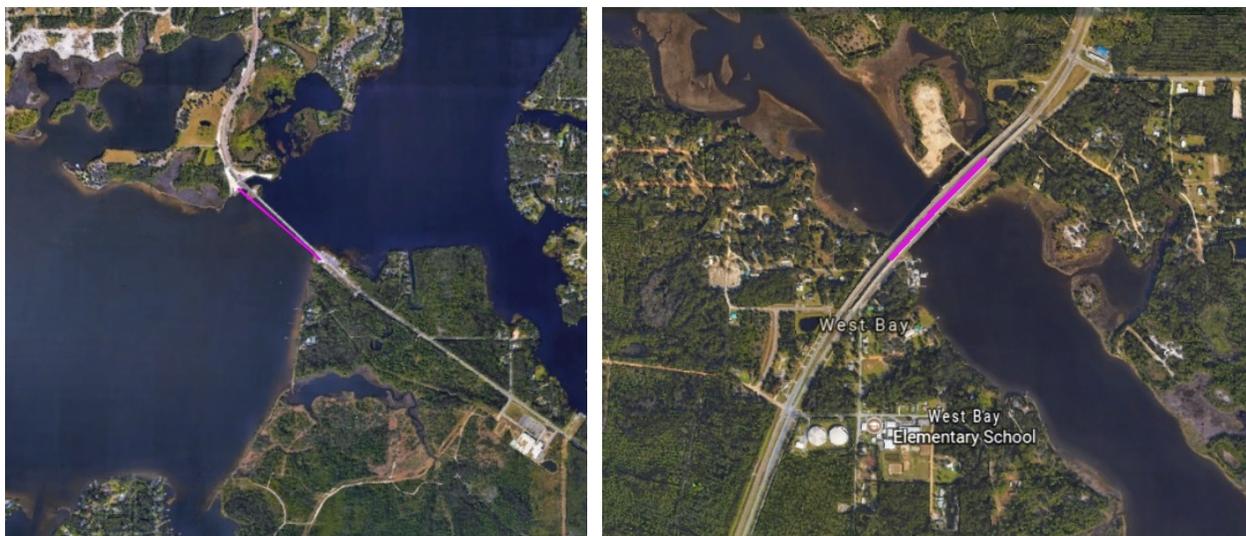
Figure 2. (left) North Bay and (right) West Bay pipe line placement (Existing lines demarked in pink)

In December 2015, the potable water transmission main crossing the North Bay (Line 1) (Fig. 2, left), located along the Highway 77 Bridge to Southport to the McElvey Plant, began leaking in a place that could not be detected from the surface (see Fig. 2, left). Stretching 2,400 linear feet from the eastern shore to the west, Line 1 was integral to supplying water to the City. As the existing pipe used in the initial installation was not a fused product, the most likely scenario is that a leak had sprung at one of the collared joints due to deterioration with age.

Within the same timeframe that Line 1 had initially been installed, a similar sub-aqueous crossing had been installed consisting of approximately 1,100 linear feet of pipe beneath West Bay (Line 2), connecting the West Bay Plant to the main system (Fig 2, right). In an effort to lessen the chance of a similar failure, Bay County moved forward with replacing Line 2 with the same design approach to avoid another failure previously experienced at the North Bay crossing. No testing was completed on Line 2 prior to the decision to replace it, but by pre-emptively completing the work, Bay County hoped to avoid repeating the same potential pipe failure.

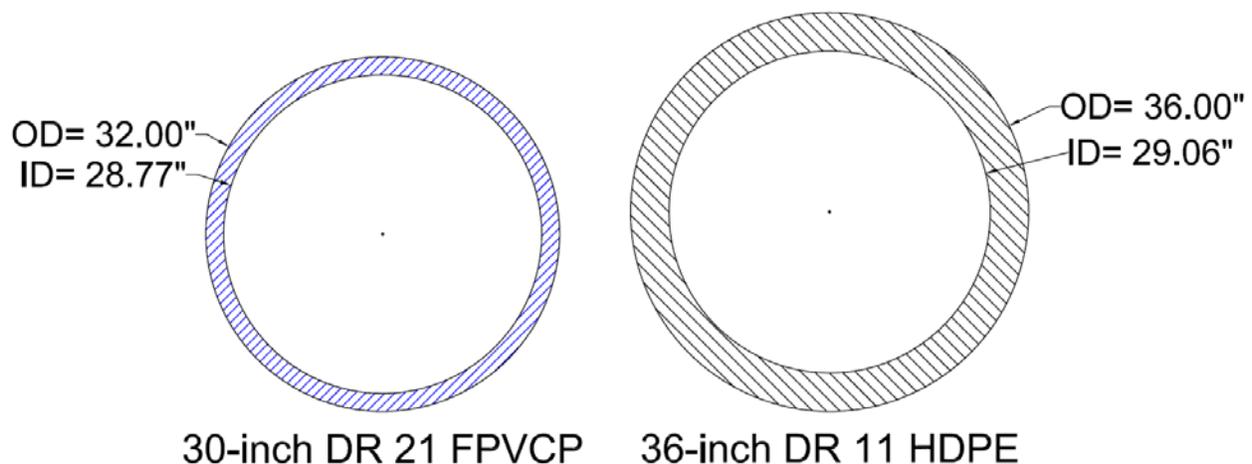
Figure 3. Pipe comparison of 30-inch FPVCP and 36-inch HDPE.

Since the pipe material had been chosen by Bay County prior to contacting Dewberry | Preble-Rish, there was no need to walk through a material selection. Due to its smaller outer diameter, 30-inch FPVCP was used, reducing the size of the borehole needed and providing a comparable inner diameter to the existing pipe. This allowed Bay County to save on installation while providing the same hydraulic capacity, and thus quality of service, to the residents of the City while also minimizing the outer diameter and required thickness of the pipe (see Fig. 3).

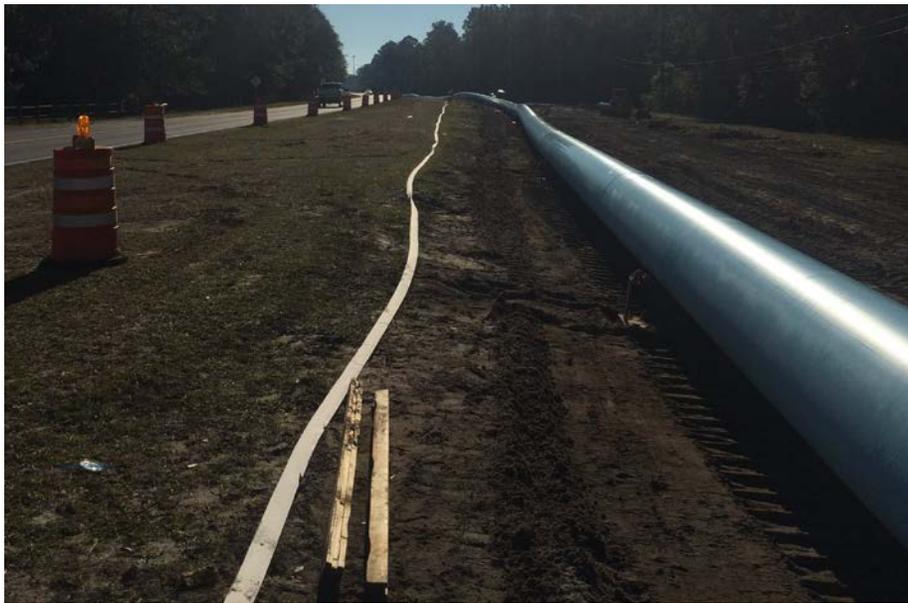
Figure 5. Pipe layout along road at North Bay right of way.

During construction on both sites, traffic maintenance was required by the Florida Department of Transportation. The initial layout for Line 1's pre-installation had to be rethought. In order to follow the two-lane road that ran parallel to the right of way, the pipe string would need to traverse a curve that would test its bend radius. (See Figure 5) In an effort to ensure a successful layout, a solution was found through obtaining permission from the adjacent land owner to allow the laydown of the pipe across the privately-owned pasture, located along the right of way.

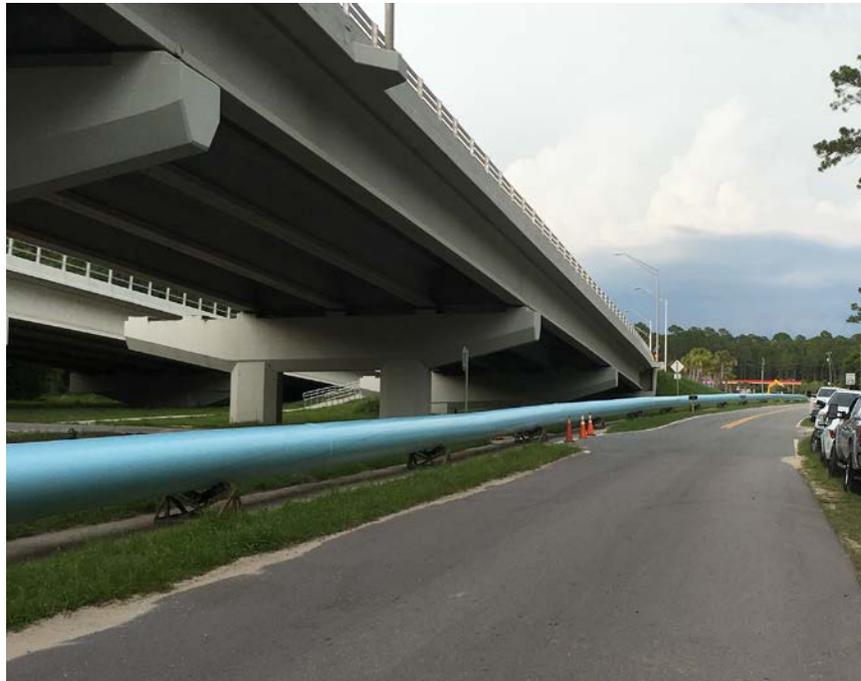
Figure 6. Pipe layout below bridge at West Bay.

The drill and pull equipment for Line 2 was located in a spot that had even less of an impact on area residents than Line 1 (see Figure 6). Since the pipeline would be located directly under the bridge, TB Landmark was able to set up their equipment in an overflow parking lot used by local restaurants during busy times. As the work was completed during the off season, this lot was seldom being used and allowed the construction workers to arrive and depart as needed with minimal interruption to local businesses.

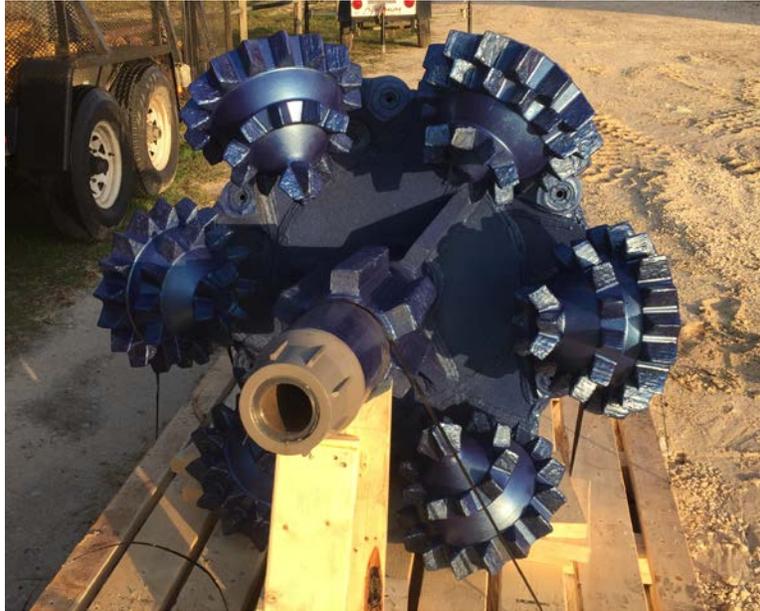
Figure 7. Custom 48-inch tricone drill bit ordered by TB Landmark for the Bay County project.

The entrance pits used for each drill measured 12- by 20-feet and the exit pits were 6- by 20-feet. The initial pilot bores were 10 ⁵/₈-inches in diameter. Once those had been successfully completed, additional reaming passes were completed at 24-inch, 36-inch, and finally 48-inch cuts successively (see Figure 7 for the custom made tricone bit used by TB Landmark). Once the bore holes were completed and found to be stable with a final swab of 44-inches, the pipe was pulled into each alignment using a 30-inch pull head. There were no issues during pull ins with Line 1

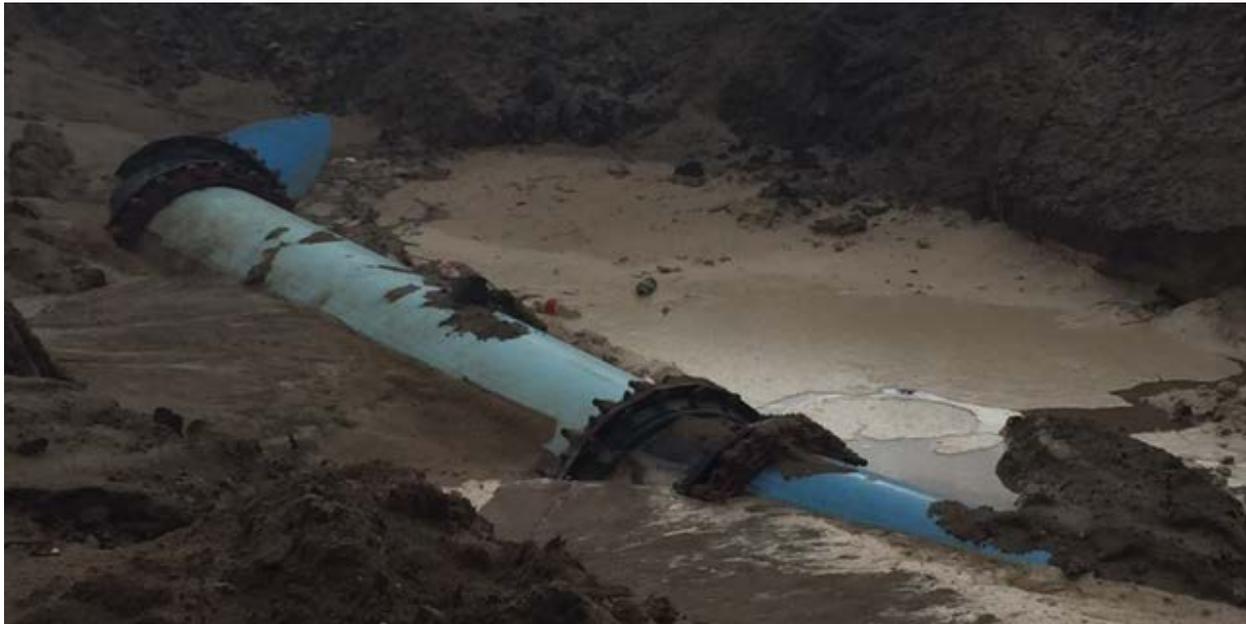
Figure 8. Pipe connection made at North Bay.

Line 1 was successfully installed in mid-February (see Figure 8). The pipe of Line 2 remained in place during the start of the summer season, and was successfully put into operation in by the beginning of August. After the pipes had been pulled into place, they were required to pass a sustained pressure test. Each pipe had to maintain a consistent pressure of 150 pounds per square inch (psi) for 2 hours. Both Lines passed, Line 1 on February 24, 2016 and Line 2 on August 8th later that year.
