**North American Society for Trenchless Technology (NASTT)  
NASTT's 2018 No-Dig Show**

**TA-T6-04**

**Virgin Valley HDD Cased Crossing**

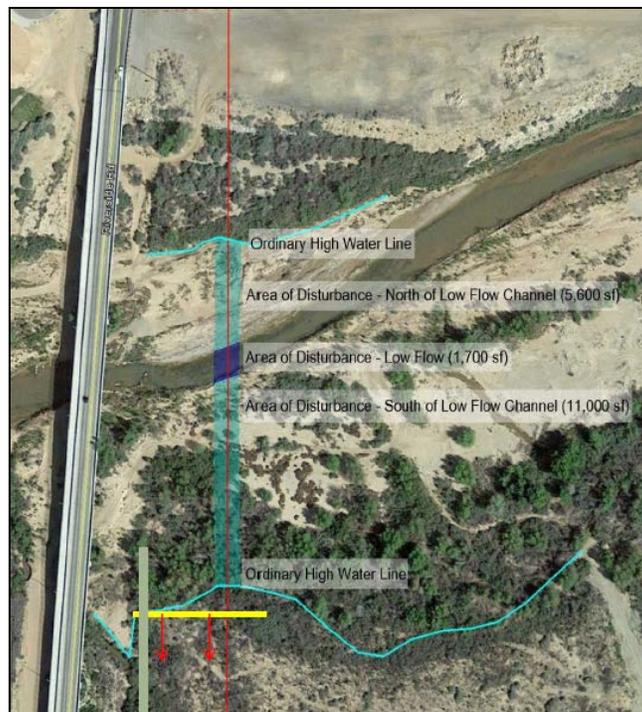
Figure 3. Proposed wetland impacts.

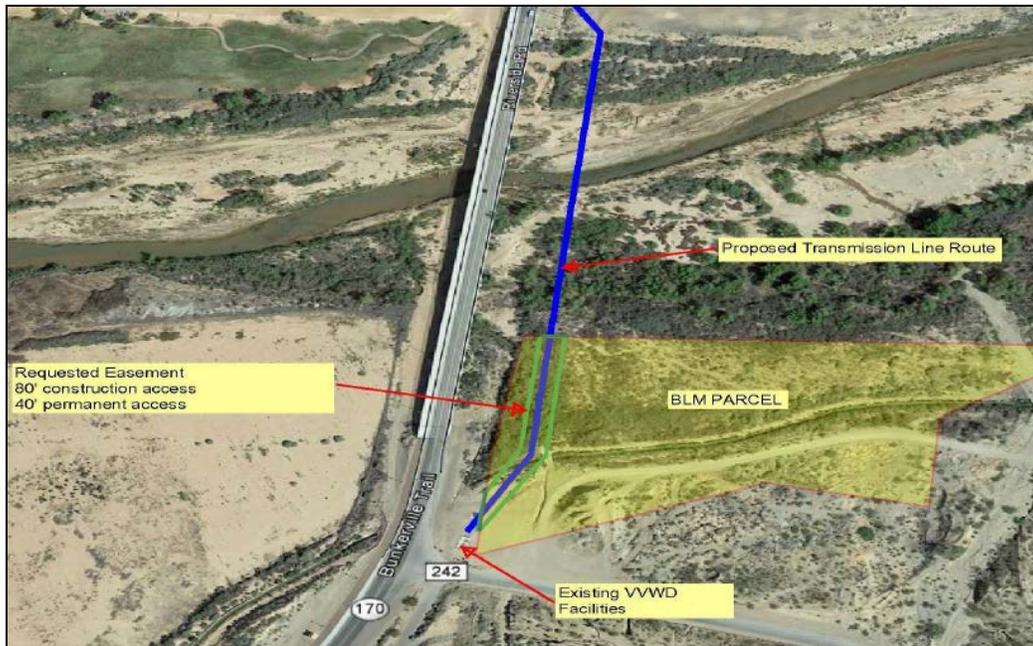
Figure 4. BLM easement location.

impact as well as protect aquatic life. The original scope of work included approximately 1,360 lineal feet of 16-inch PVC potable water carrier pipe with approximately 600 lineal feet of 30-inch PVC casing pipe. The selected installation method was open trenching with dewatering, for which the District had already obtained a permit. Since the entire length of the project passed through properties owned by various entities - including the Bureau of Land Management (BLM), the City of Mesquite, and private owners - the District had to obtain the appropriate permits before construction began (see Figure 4).

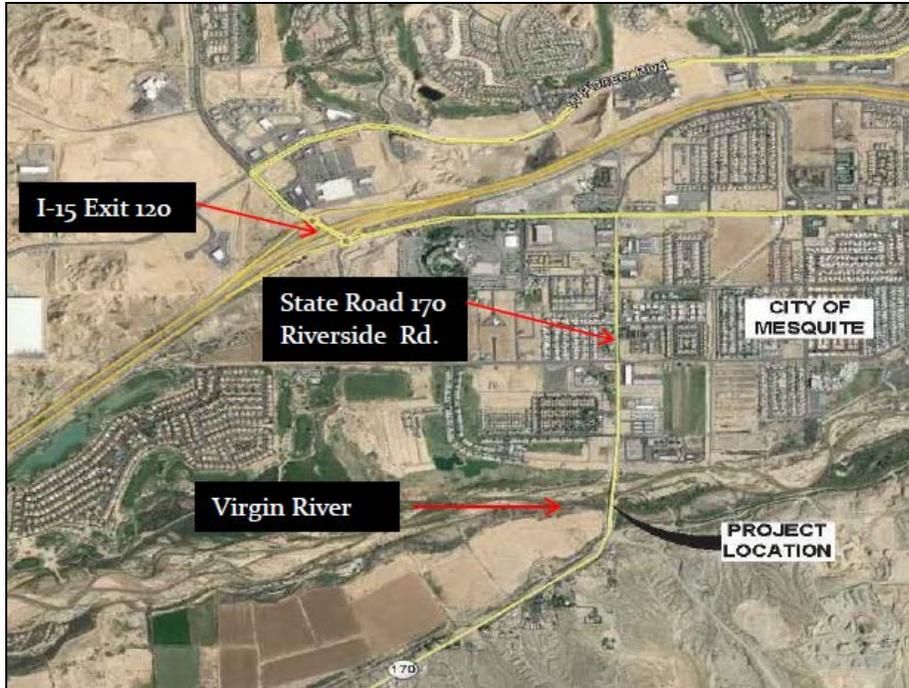
Figure 5. General map of project construction

Construction began in March of 2017 on the south side of the project (see Figure 5). While drilling the pilot hole, the contractor encountered a minor loss of returns, and an inadvertent return was found approximately 10 feet north of the Virgin River active flow channel. Quick action was taken to mitigate the release, with both the contractor and engineer following the emergency response procedure that was put in place before construction began. VVWD was notified that a minimal amount of fluid was released on the north side of the river. Both the contractor and engineer explained to VVWD and the Nevada Department of Environmental protection that the amount of bentonite released into the river was non-toxic and non-invasive. The release was logged and photographed for record purposes and no violations were issued (see Figure 6). Since this minor incident was quickly resolved, it did not cause any delays in the installation. Once the release was contained, construction continued with no additional events.

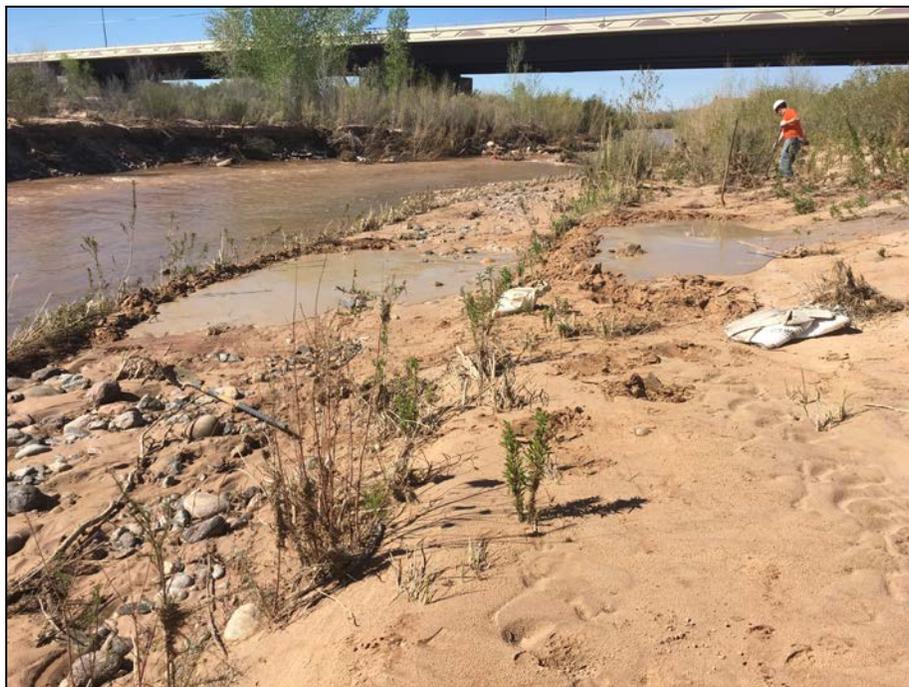
Figure 6. Release of bentonite as a result of minor frac out event.

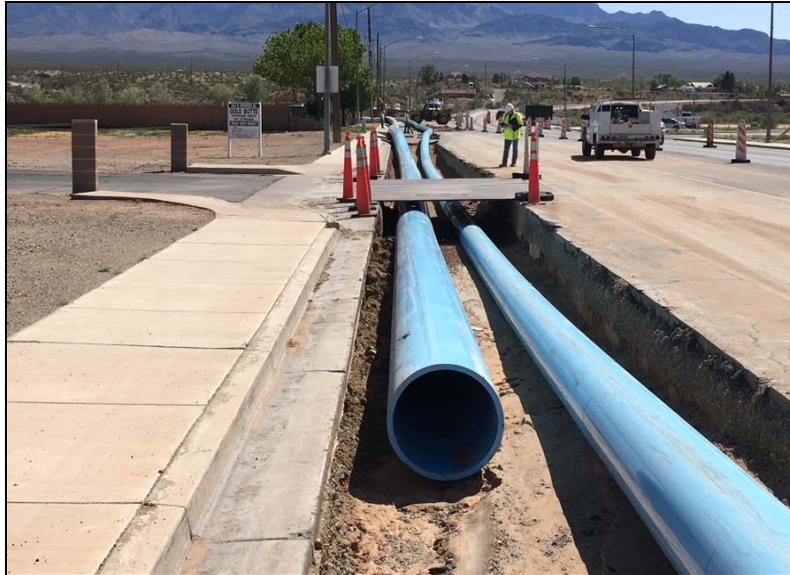
Figure 7. Carrier and casing pipe fused and ready to pull in.

The majority of the project was located in open space, far from residences. This caused minimal issues with pipe staging and equipment layout. The carrier pipe was staged and laid out on the north side of the project, adjacent to the casing pipe, before installation (see Figure 7). VVWD received permission from the City of Mesquite who owned an acre of open unused land approximately 0.2 miles north of the project site. For the duration of construction, this land was used to store miscellaneous equipment for the project. Also, since there were plenty of areas available for staging, storage, and layout, traffic was not affected during the pipe installation. There was, however, a wastewater treatment plant on the north side of the project near the pipe staging area. Using fork lifts,

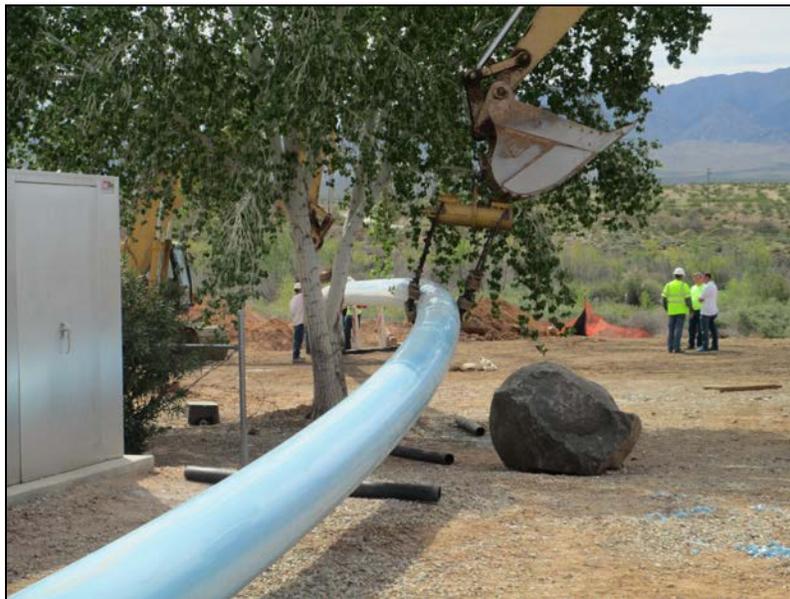
Figure 8. Pipe staging around the city wastewater treatment plant.

excavators, pipe roller “cradles”, and personnel to direct the pipe around the tree during pull back, the pipe was maneuvered around a tree that stood next to the treatment plant (see Figure 8). All pipe staging was strategically planned to ensure that the pipe was properly supported and that it did not exceed the minimum bend radius recommended by the pipe supplier.

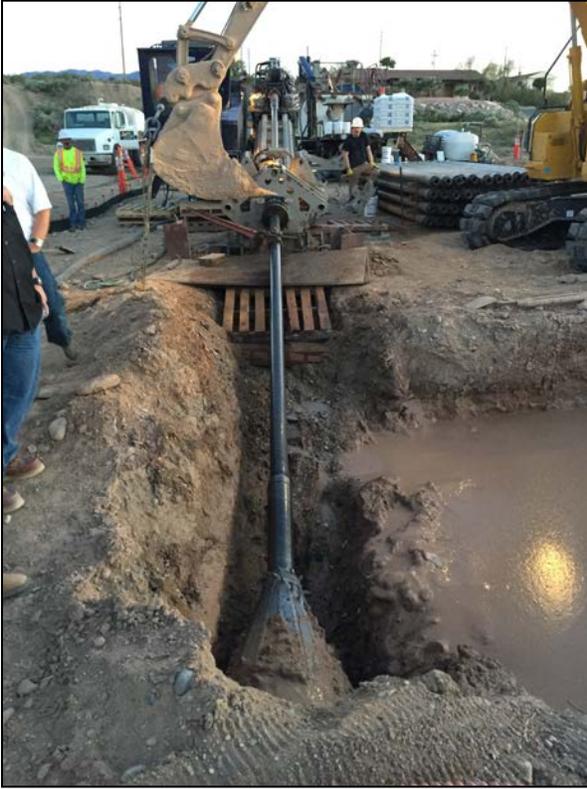
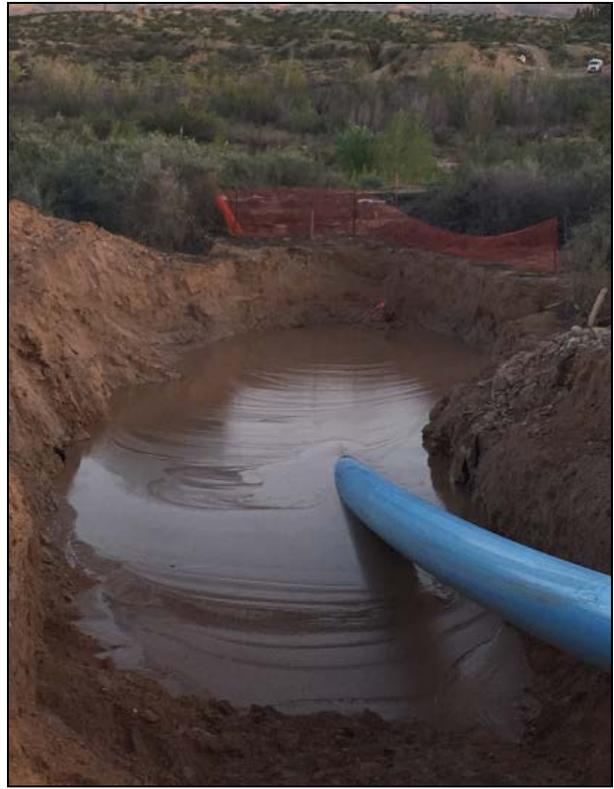
Figure 9. Casing pipe installation with casing pipe at exit pit (left) and casing pipe on north (entry) side of project (right).

The pilot hole was drilled and it measured approximately 12 to 14 inches in diameter. The hole was enlarged by reaming steps until sufficiently sized for the 24-inch casing pipe. The 24-inch casing pipe was installed without disruption after preparation of the bore hole was complete (see Figure 9).

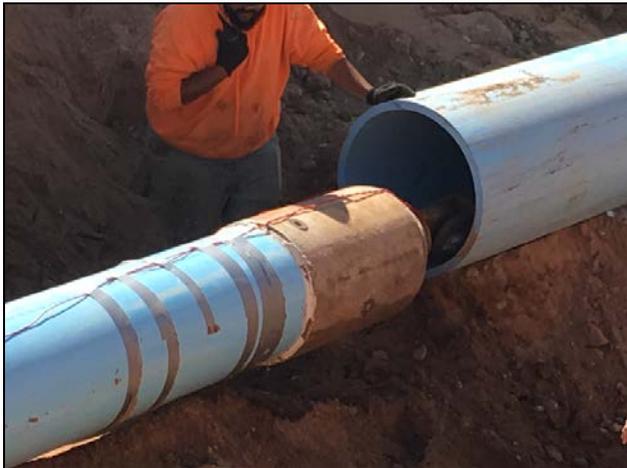
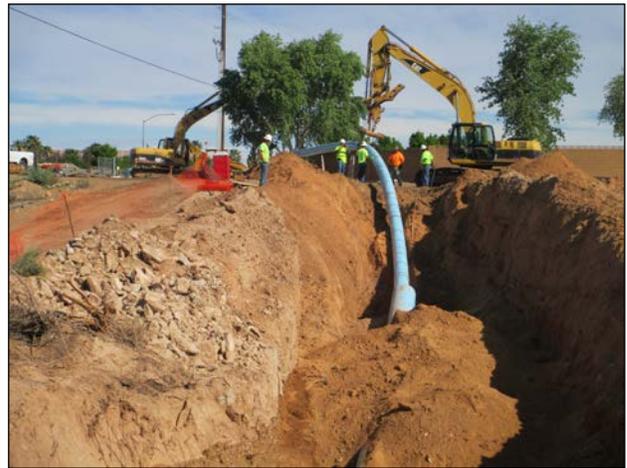
Figure 10. Carrier pipe being pulled into the casing pipe. Initial insertion (left) and alignment around the tree to the insertion point (right).

After the casing pipe was successfully pulled into place, the 16-inch carrier pipe was placed on rollers in preparation for insertion into the casing pipe (see Figure 10).
