## Slipline Methodology Rehabilitates Large-Diameter Water Main

Because of increasing leaks in a water main and costly repairs, a Virgin Islands utility turned to slipline technology to rehabilitate the main, minimize commercial disruptions during the rehabilitation, and mitigate corrosion. **MUSTAFA ABUSAUD AND RICHARD BOTTEICHER**

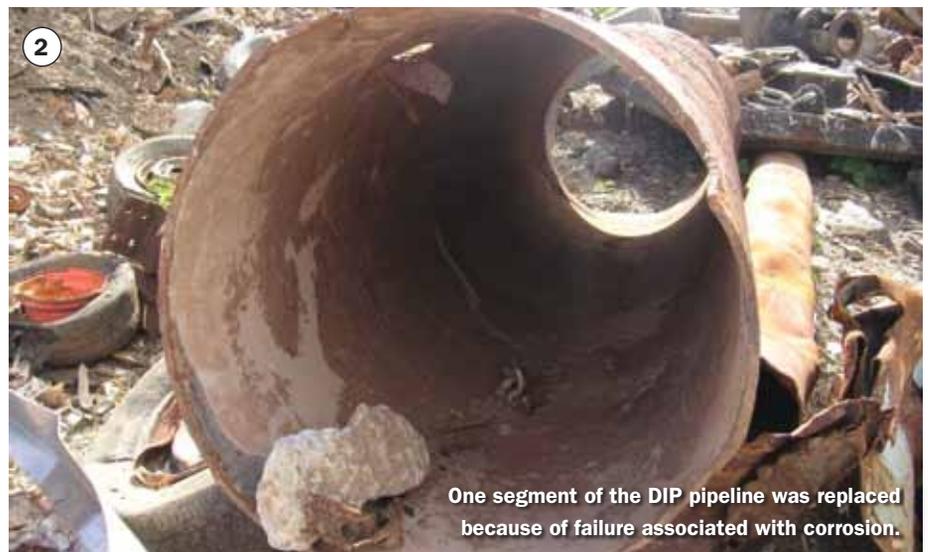
2 One segment of the DIP pipeline was replaced because of failure associated with corrosion.

Over the years, various problems with the 24-in. DIP pipeline arose, particularly those caused by pipeline corrosion resulting from exposure to harbor-influenced groundwater below the concrete pavement (Photograph 2). The pipe sits above the surface in three locations to accommodate conflicts with other utility lines and the shallow nature of the pipeline (Photograph 3). These locations enable personnel to easily observe and assess

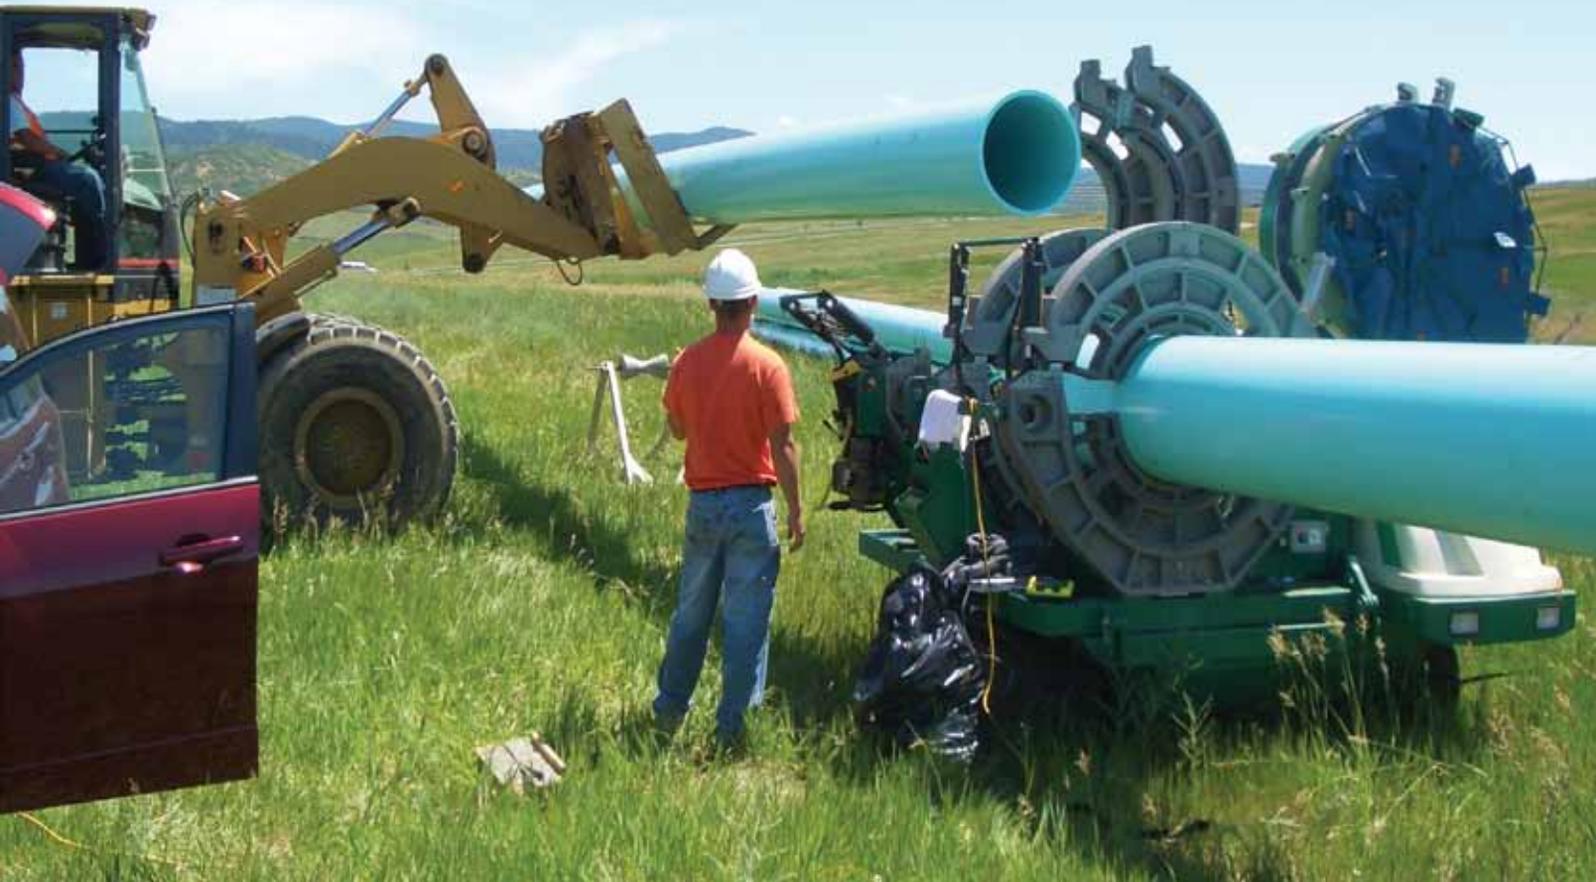
FPVCP was loaded into a typical fusion machine to be joined.

FPVCP uses a thermally fused or bonded connection instead of a mechanical and/or gasketed connection like other PVC pipe-joining technology used today. Two plain-end lengths of FPVCP are joined by heating the ends of the pipes until a fusible bead of material is formed on each, and then the pipe ends are brought together and held under pressure until they cool to ambient temperature.
