# Pearl City Force Main Repair

Kyle Kaneshiro, P.E.  
Joe Kwan, P.E.  
The Limtiaco Consulting Group

**The City and County of Honolulu (CCH) faced a serious public health and environmental problem with one of its large-diameter dual wastewater force main systems after experiencing four breaks between April 2006 and July 2010.**

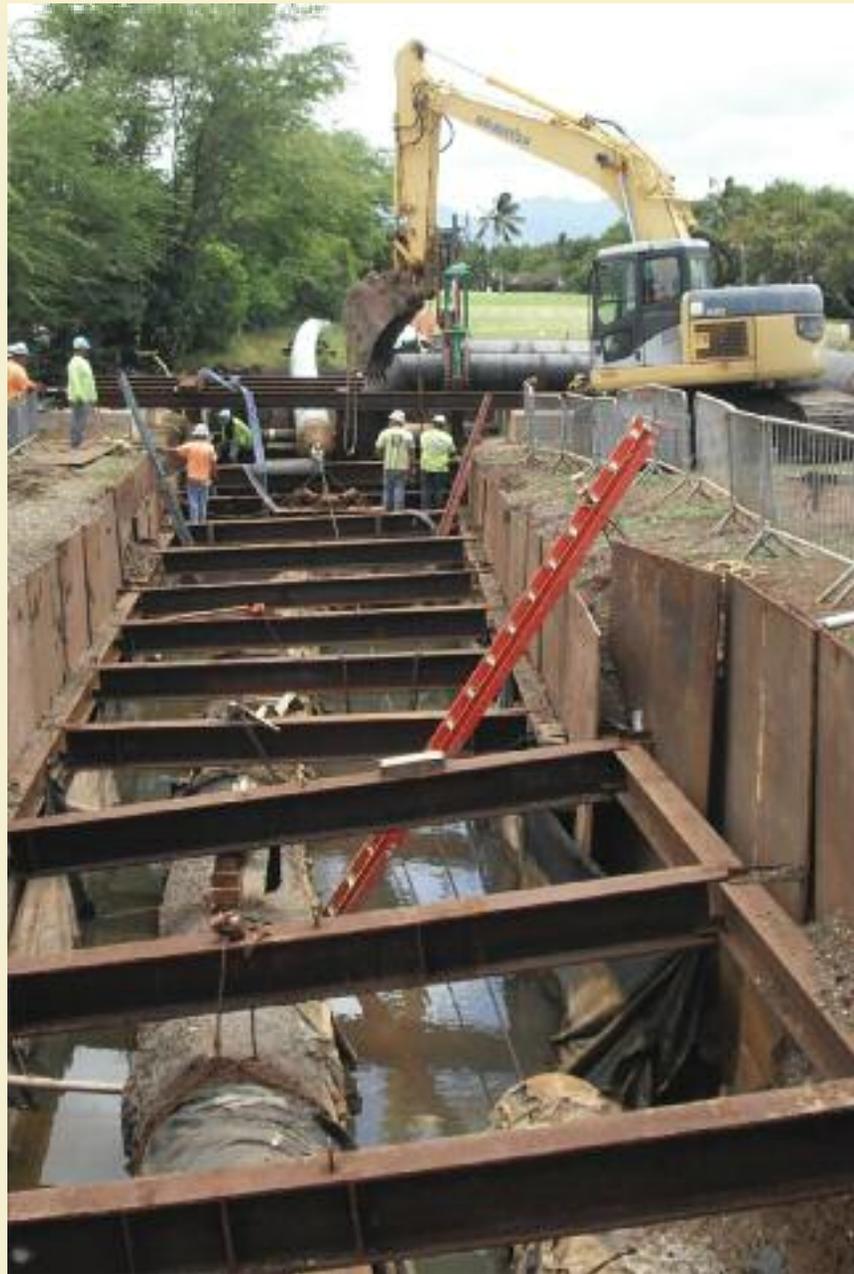
*Pulling the new 24" Fusible C905 pipe into the borehole while working over existing meter station and Caltrans signalized intersection.*

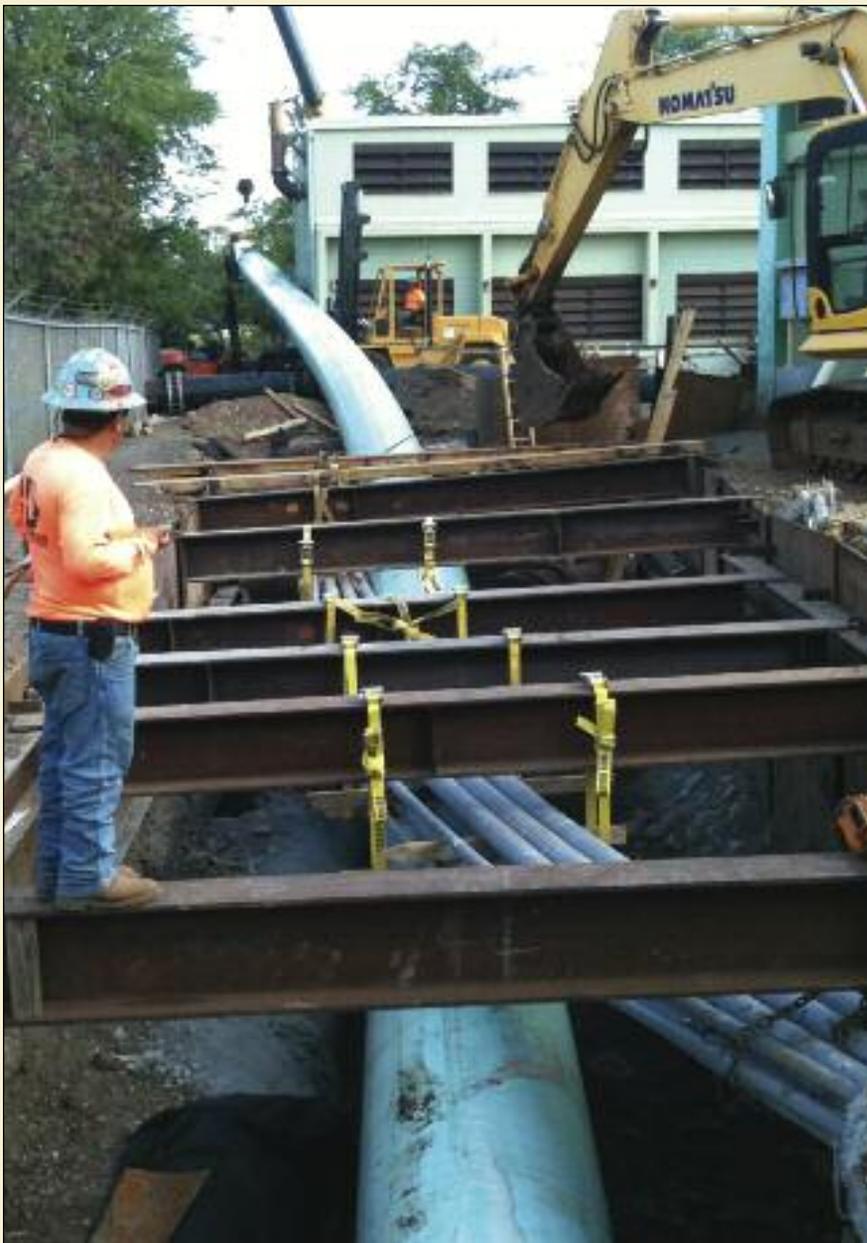
*Site constraints included an uncovered electrical duct bank*

Site constraints had a big impact on this project. Proximity to the pump station and force main system alignment made it difficult for the contractor to make a direct insertion. Furthermore, during excavation of the entry pit the contractor uncovered a concrete electrical duct bank (not shown in location on as-builts). The duct bank turned out to be the main electrical feed for the pump station backup power. Interruption of the electrical feed or moving the pump station were not feasible options, so the contractor decided to bend the fusible PVC pipe around the pump station building and electrical duct bank, into the host pipe. To minimize the pipe deflection and assist with the sliplining process, the contractor extended the entry pit and used a pulling head on the fusible PVC pipe.

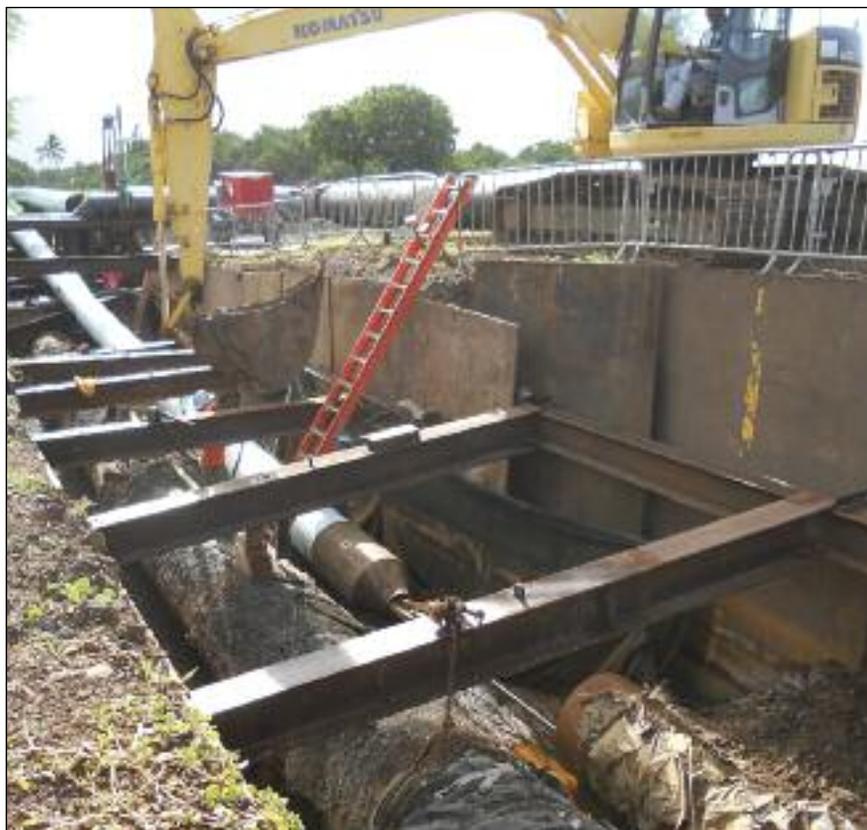
*Pulling Fusible C905 over the adjacent drainage channel and into the 30-inch force main*

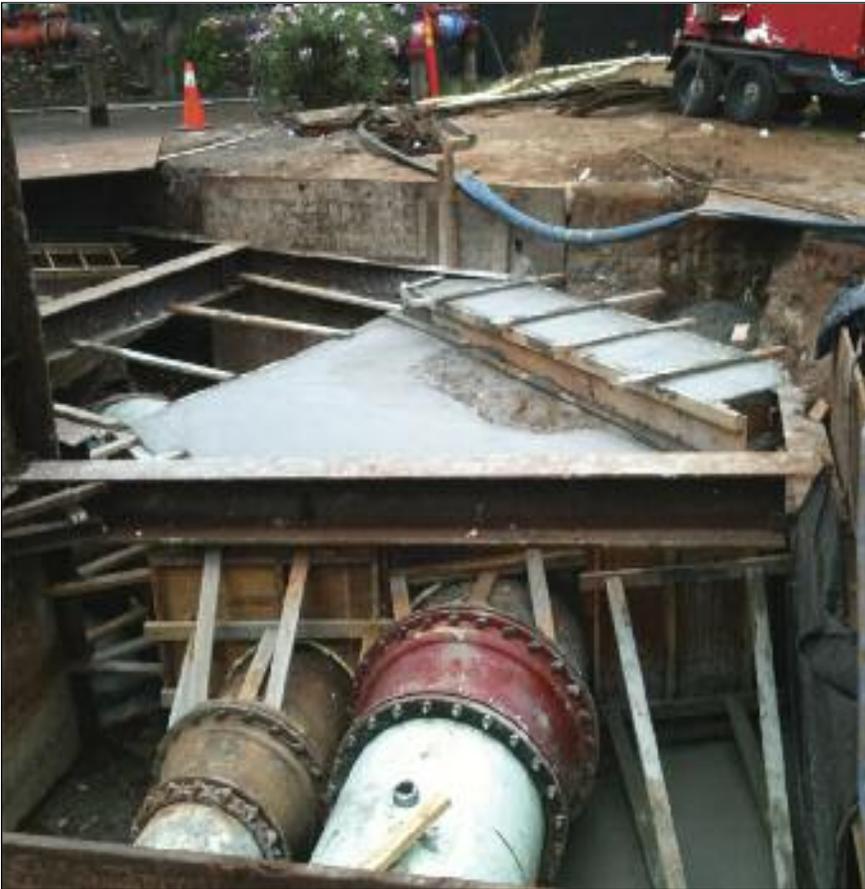
*Receiving pit at existing 74-degree bend*

After the sewer bypass system was constructed, repair of the force main system proceeded from the upstream end. The contractor exposed the unconventional bends to confirm the angles and determine their condition. Fortunately, the bends appeared to be in good condition and a collaborative decision was made to retain them in place and restore the cathodic protection system. The design was modified with additional pipe fittings to accommodate the bends.
