ROUTE 5 WATER MAIN IMPROVEMENTS – BELLOWS FALLS, VT

Asbestos Cement Pipe Bursting

By: Christina Haskins P.E., Dufresne Group

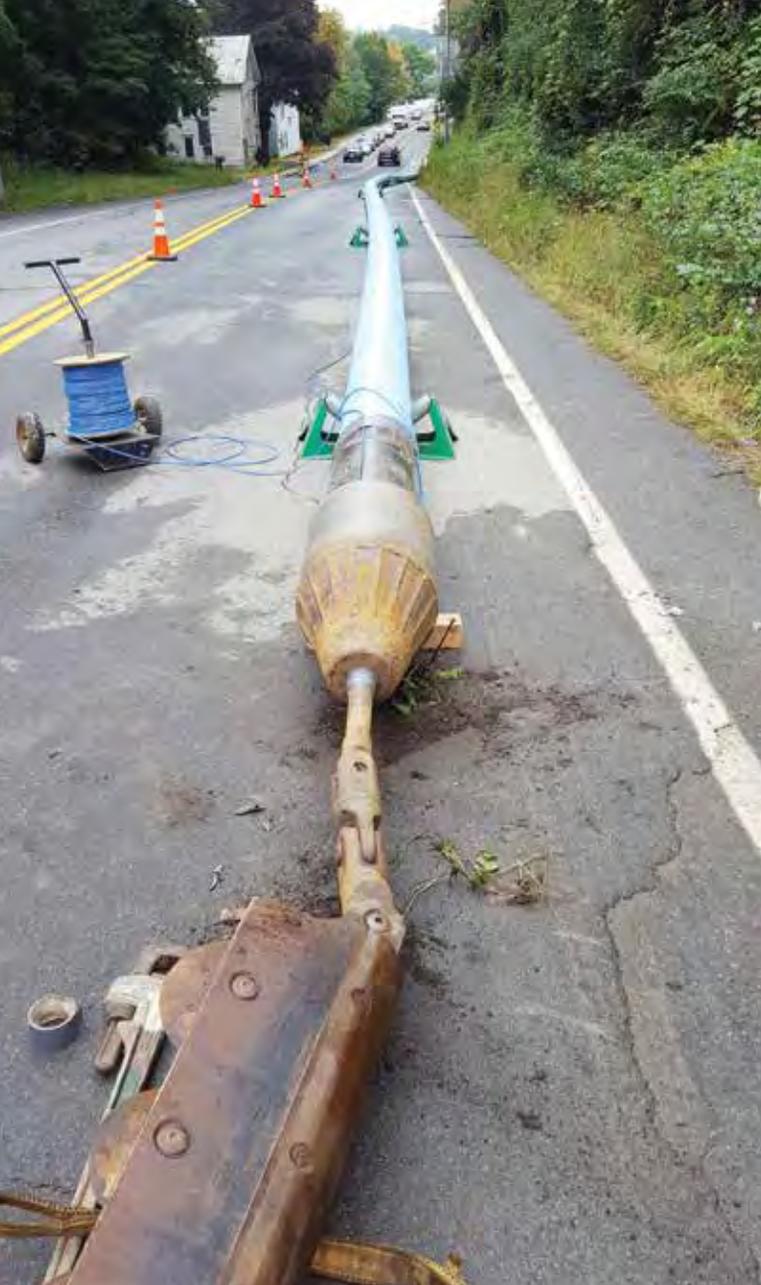
New Pipe Laid Out on Cradles

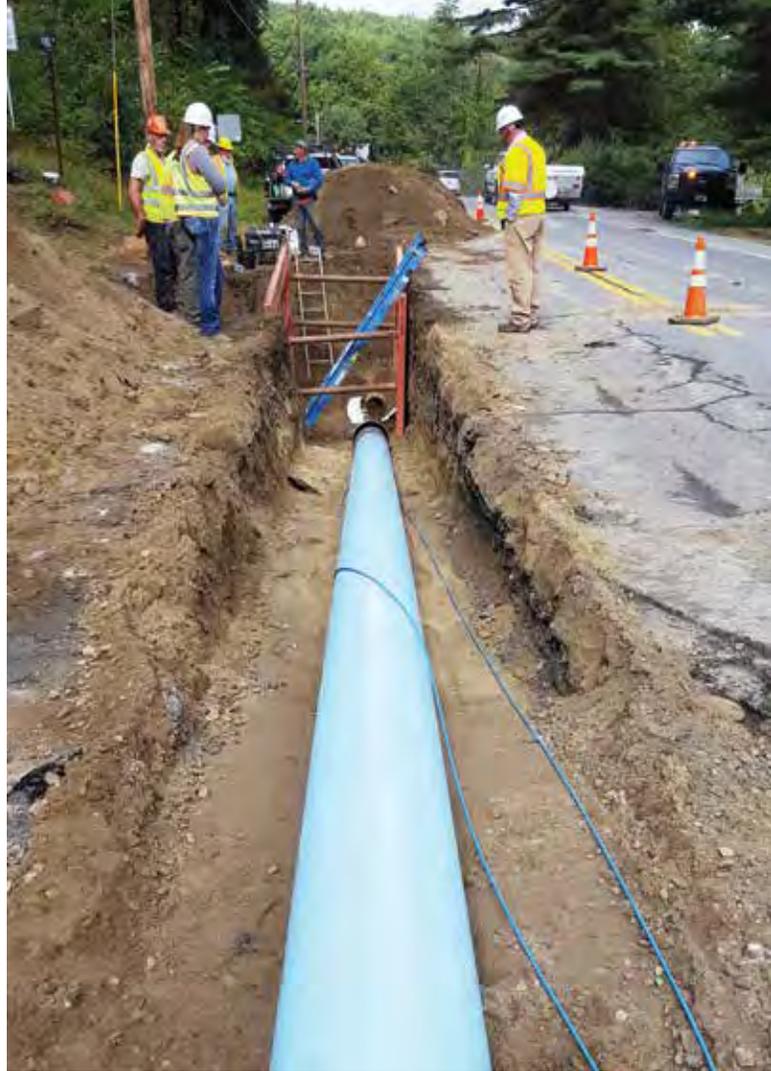
Pipe Insertion Pit

To pipe burst a water main, pits are first dug at a ‘machine’ or ‘pulling’ location and at a ‘pipe insertion’ location, usually between 300 and 700 feet apart. Threaded or linked rods are fed through the host pipe from pulling side until they exit on the pipe insertion side. Tooling that can both split and burst the host pipe is attached to a lead rod, then an expander is added to expand the split and fragment existing pipe to create a void. The expander head is connected to the pull head and pipe – in this case 12-inch FPVCP. Finally, the machine engages and pulls back the rods, tooling and product pipe through the entire length. This method typically reduces excavation by approximately 85 percent.

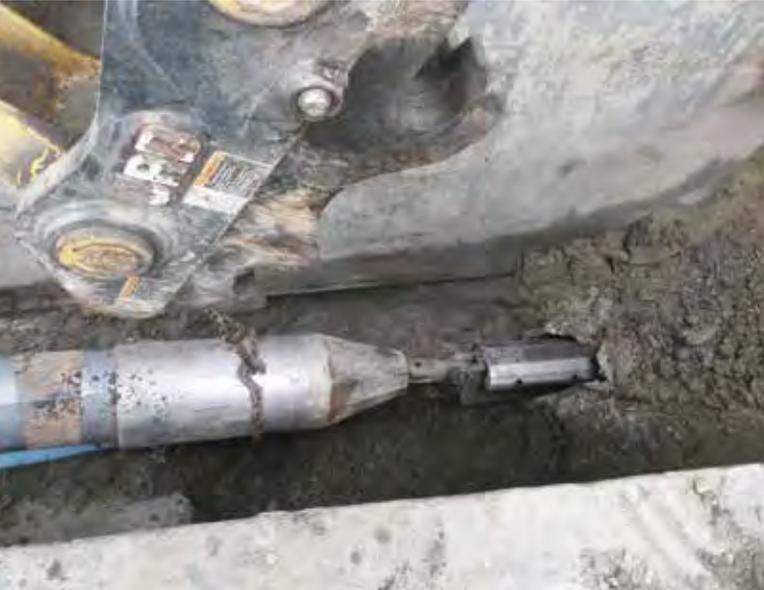
Cutter Tooling and Expander Head Entering Host AC Pipe

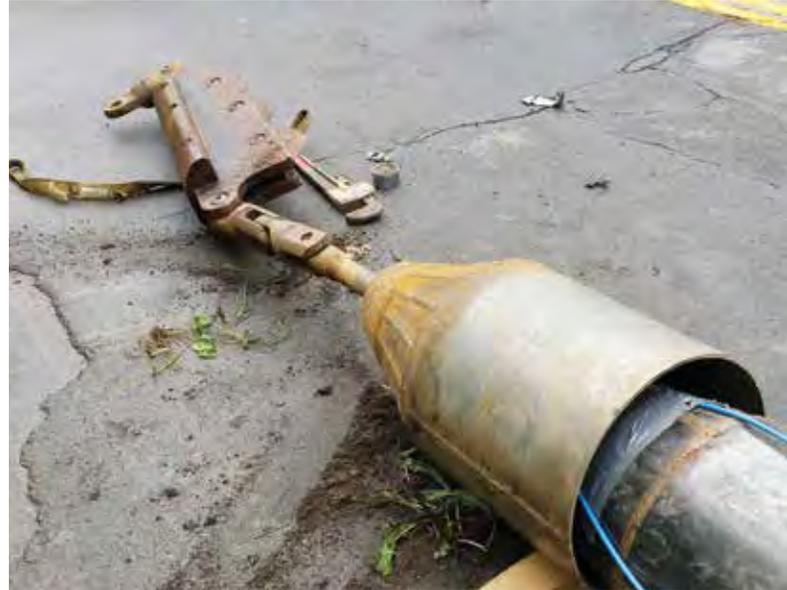
Cutter Tooling and Expander Head Assembled

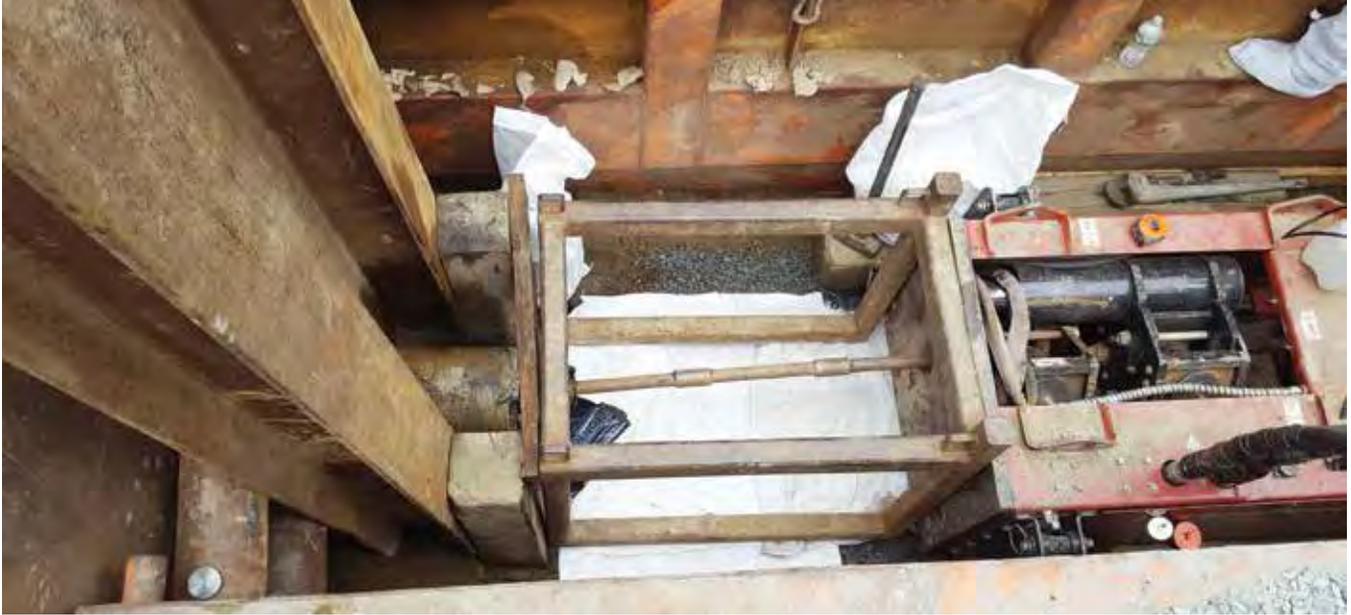
Bursting Machine Setup in Pulling Pit
