Pipe-Bursting Challenges Provide Valuable Lessons

Problems surrounding the rehabilitation of a leak-prone water transmission pipeline were solved through cooperation and hard work. In the process, the city of St. Helena, Calif., gained valuable insights for future projects. **BY COLLINS ORTON**

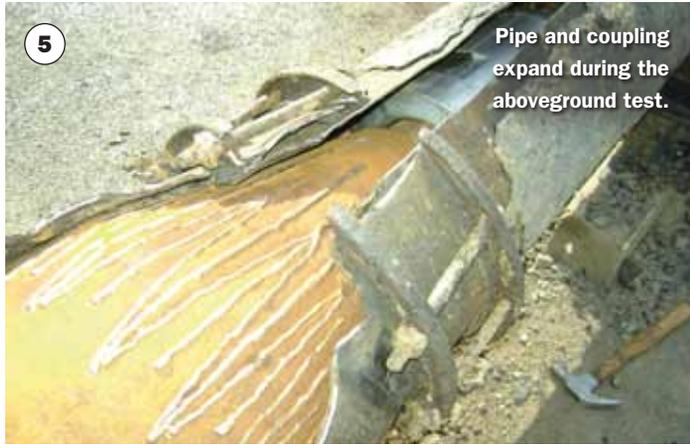
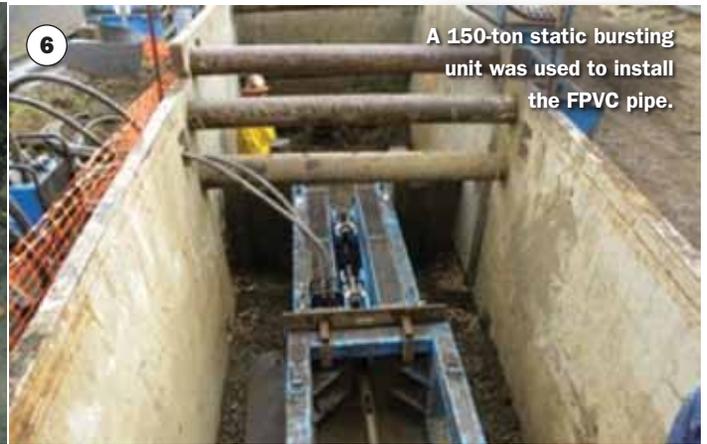
crews had to continually dewater the site and extensively shore the machine and launching pits.

When the excavation was prepared, the contractor's crews threaded the exiting pipe with bursting rods at the insertion pit, and the cutterhead, expander, pulling head, and FPVC pipe were attached (Figures 7 and 8).

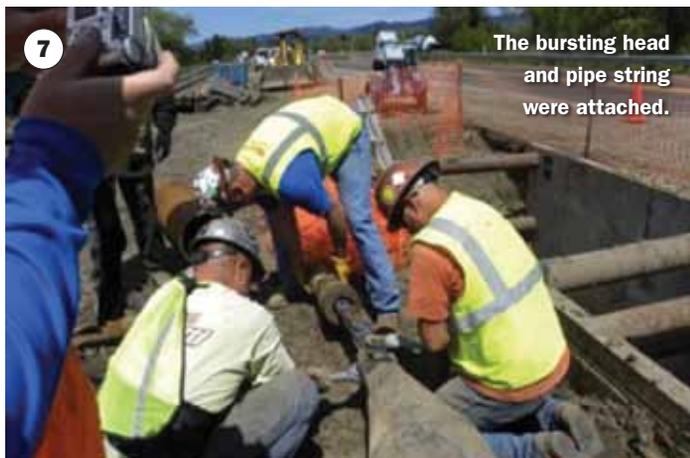
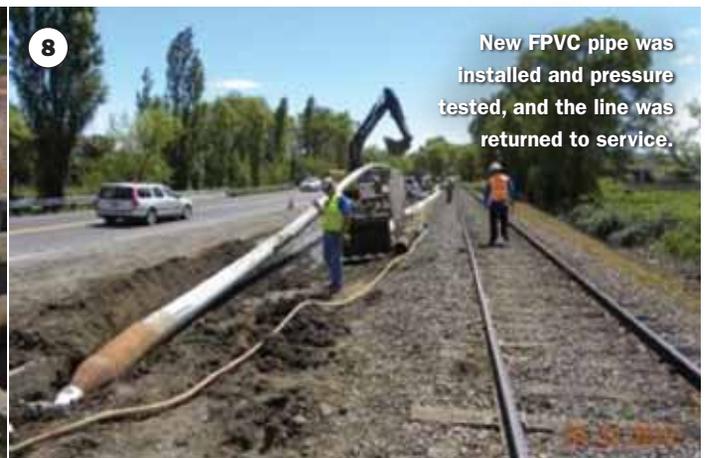
The first run was completed in about 2.5 hours of actual bursting time without incident. The second run was performed two days later. To burst the 320-ft pipe section, the bursting unit, which was still in the machine pit, was turned 180 degrees. The next pipe section was rodded, and the cutterhead, expander, and new FPVC pipe were attached. At the second two-way pit, the static pipe-bursting machine was shoe-horned into a vertically tight pit with multiple electric

conduits visible in the upper portion of the excavation. Ultimately, each run was successfully burst and replaced in a couple of hours.

The static-bursting machine—with pulling forces within its working range of 150-US ton capacity—operated without interruption. The cutter and expander reliably split, cut, and expanded the 12-in. steel pipe and couplings in each bursting run.
