Washington, D.C.  
March 27-31, 2011

## Paper F-1-05

# CONTINGENCY PLANNING for HIGH-RISK HDD CONSTRUCTION

David J. Tanzi, P.E., BCEE<sup>1</sup> and G. Christian Andreasen, Jr., P.E.<sup>2</sup>

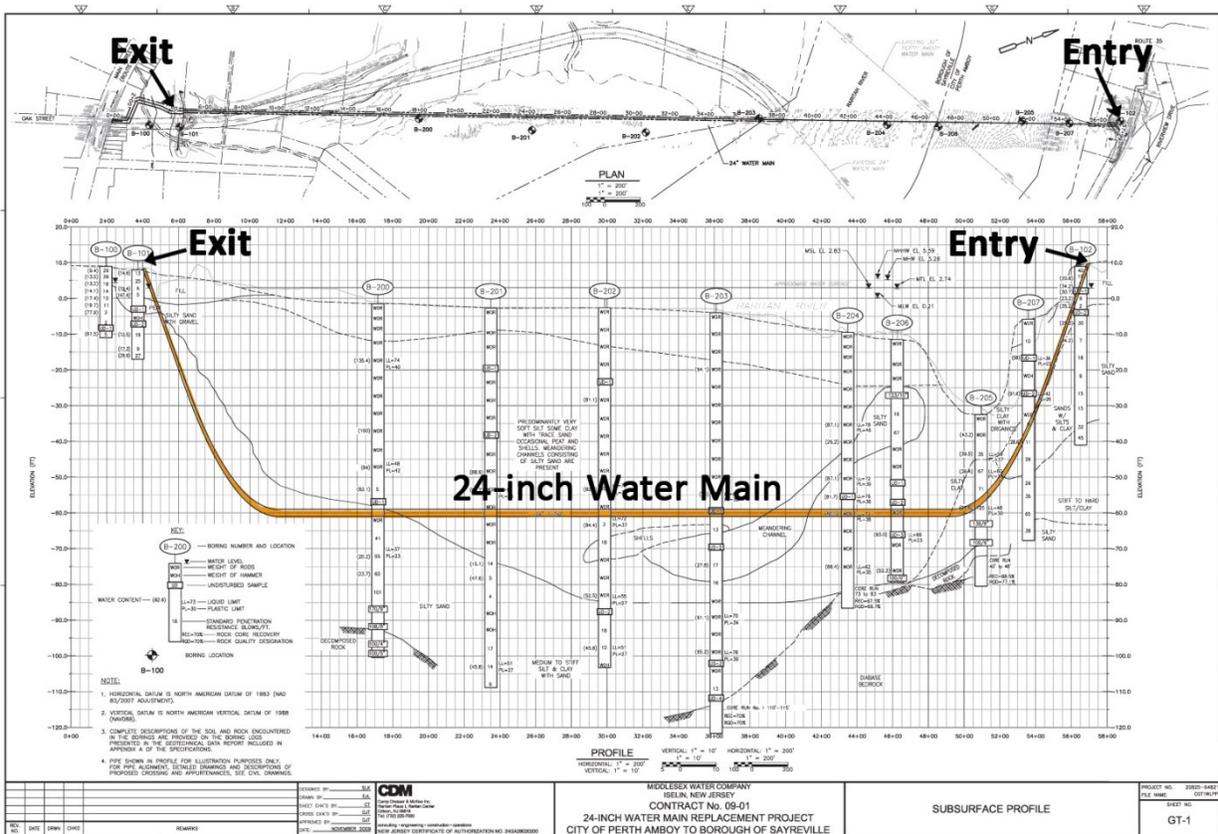
Figure 2. Horizontal and Vertical Profile

During preliminary design phase of the project, eight geotechnical borings were taken on the Raritan River and three additional borings were taken on the banks of the river. The borings in the Raritan River were performed by using barge-mounted, mud-rotary drilling methods. The marine borings extended to depths varying from 48 to 115 feet below the existing mud line. The land borings were advanced using conventional truck-mounted hollow stem auger drilling equipment, extending between 25 and 50 feet deep. The geotechnical investigation of the site revealed various zones of extremely soft silty clay overlying stiff silty clay, sand, gravel that is underlain by a bedrock shelf on the north side of the crossing. Considering the above characteristics and the technical analysis performed during the design of the project, an alignment with the deepest part of the pipe (the central section) located at an elevation of -60 feet below the mud line was recommended with radii of curvature along the entry and exit locations in the alignment set to 5,107 feet and 3,310 feet respectively, as shown in Figure 2.
